Home Inspection Report

Anyname St, Toronto, ON, M0A 1O1

Date of Inspection: 10/16/2012 Time: 1:00 PM
Age of Home: 80 years
Weather: Cold, Windy

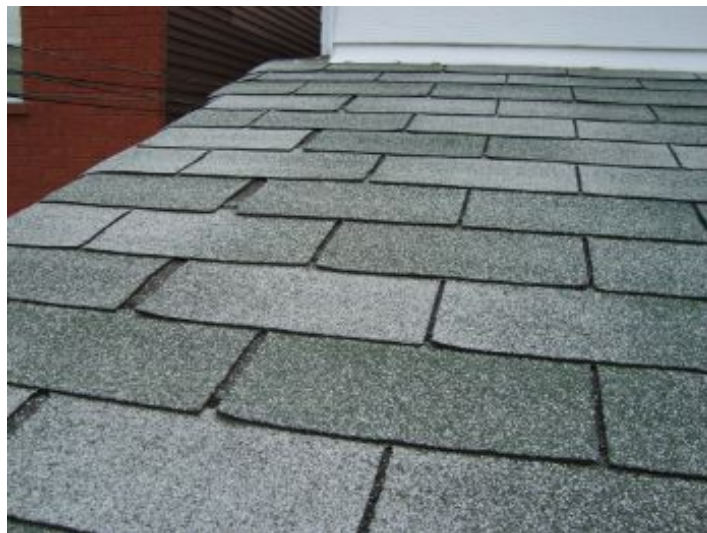
3. Roof Condition

- Waviness noted in roofing surface. This is a relatively common condition and can be a result of inadequate ventilation.
- **Granular loss and deterioration observed. Shingles are dry, brittle, cracked, cupping, and curling. Roof appears to be at the end of its useful life. Suggest further review by a licensed roofer prior to closing for repairs/replacement as needed.**

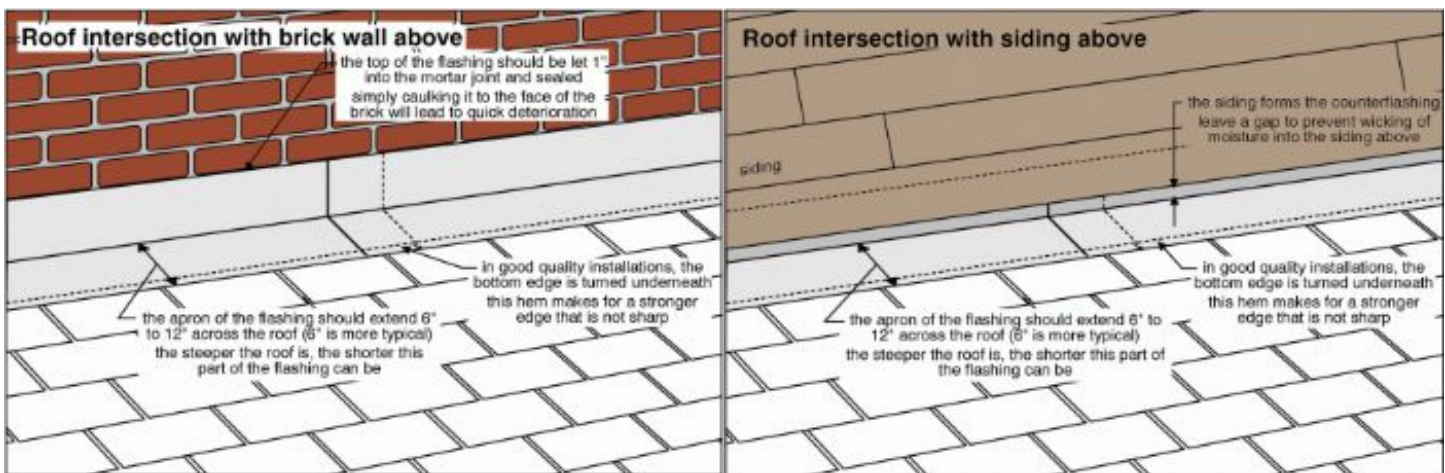
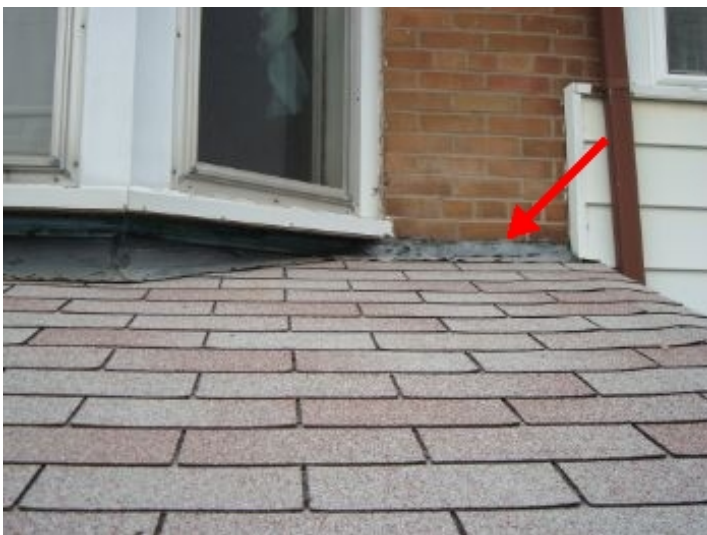
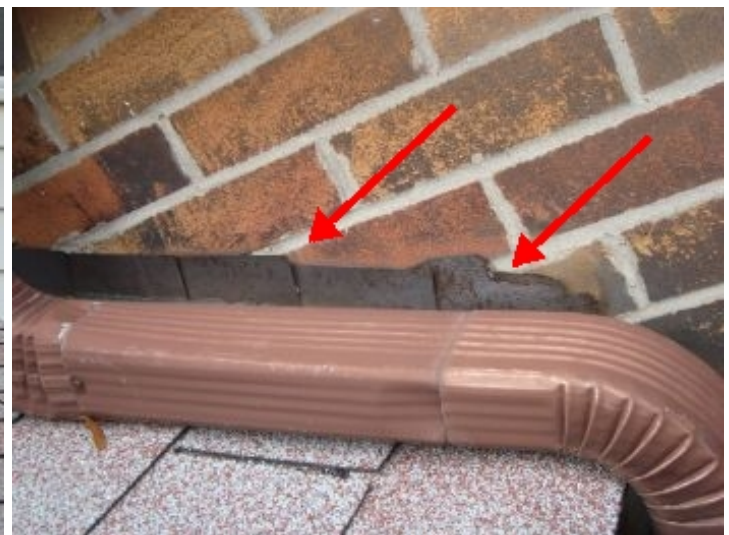
4. Roof Flashing Condition

- Flashings are mastic covered, recommend re-sealing all through the roof vents and projections as a part of routine maintenance.
- There is flashing but no counterflashing where a portion of the roof abuts the house, and moisture intrusion would be possible. Therefore, this connection will need to be monitored and serviced as necessary.
- The roof flashings need to be sealed or serviced. They are comprised of metal or neoprene material that seals valleys and vents and other roof penetrations, and are the most common point of leaks. This is particularly true of the flashings on a layered roof, which are covered by the roofing material and which are even more susceptible to leaks.
- In the inspectors opinion the flashings are near the end of their useful life due to wear. Recommend review by a licensed roofer for repair or replacement as necessary.

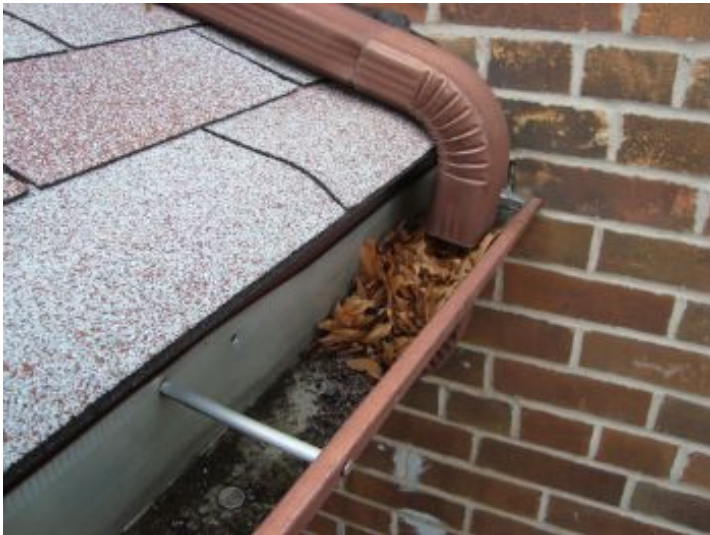
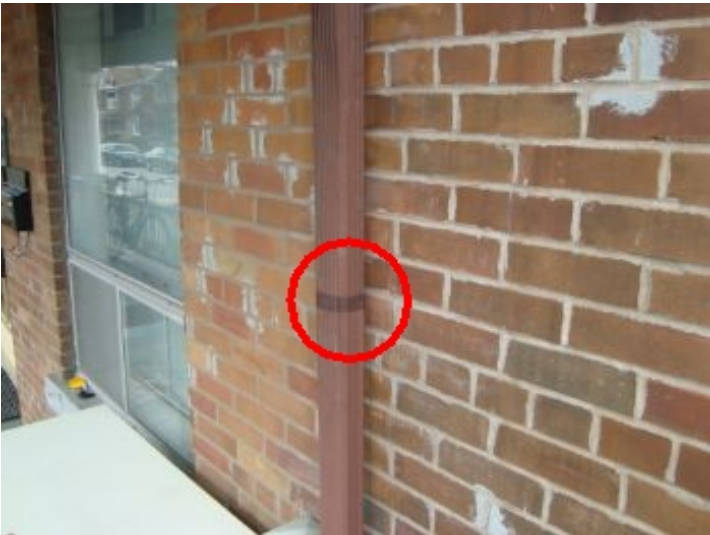
5. Gutter Condition

- Debris blocked downspouts observed. Recommend cleaning gutters and downspouts, which should be a regular part of maintenance.
- Clogged gutters noted. Suggest gutters be cleaned out as a part of a normal maintenance routine to ensure proper drainage.
- Downspout at front is loose and should be secured.

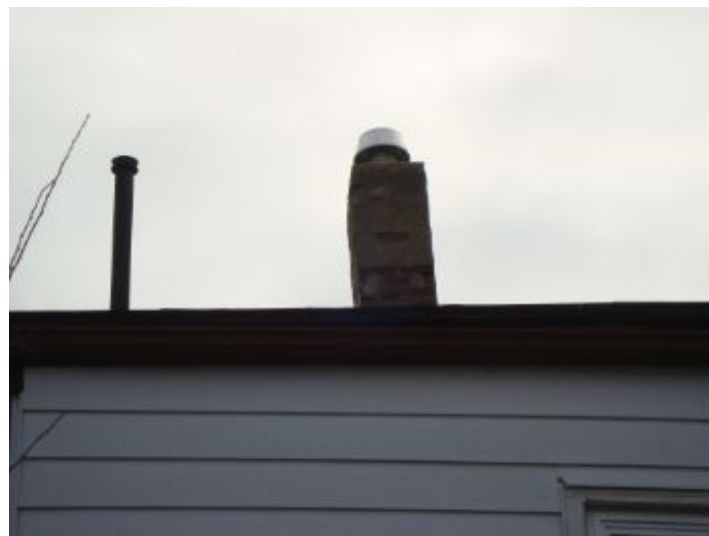
2. Chimney Condition

- Suggest rebuilding chimney crown cap to reduce opportunity for water infiltration and damage. This is a common maintenance item that is often neglected by homeowners. You should make a crown inspection part of your routine seasonal maintenance checklist. Recommend monitoring this area regularly.
- **Chimney is leaning. Recommend review and repairs by a qualified mason.**
- Evidence of repairs observed, unable to determine the effectiveness of these repairs. Recommend review by a qualified chimney professional for repair or replacement, as necessary, prior to close.

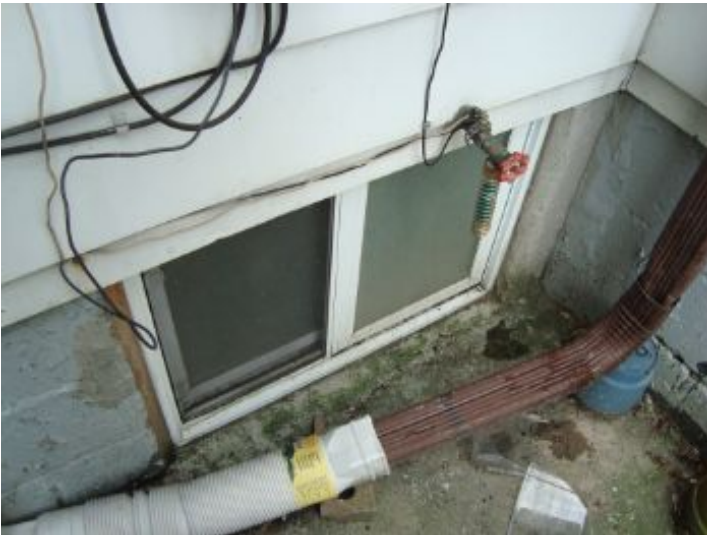
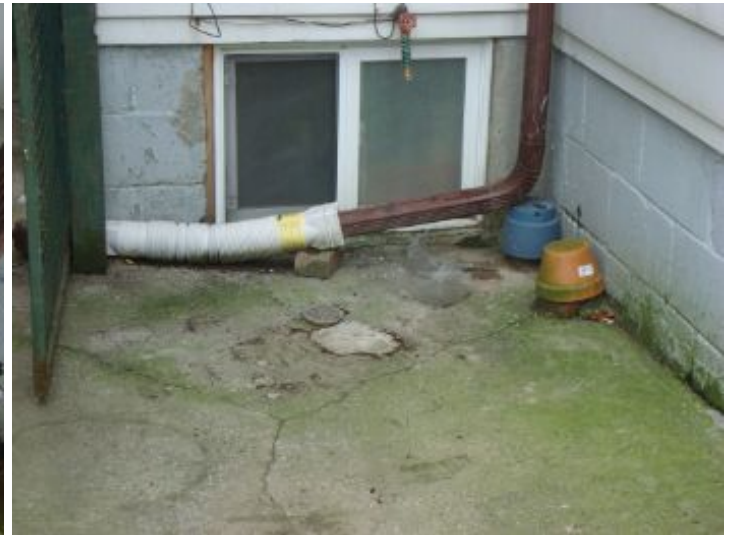
4. Lot Grade and Drainage Conditions

- There are areas where the grade is too high to wall finishes and can cause rot or damage. Finished grade should be kept at least 6 inches below brick veneer or 8 inches below siding. We can elaborate on this issue, but you should seek a second opinion from a qualified grading contractor.
- Low areas and reversed slope observed at the back yard. Re-grading where needed is recommended to assure all water drains away from the home's foundation at all times.
- Older structures do not have the same drainage features as newer structures, making them more prone to seepage.

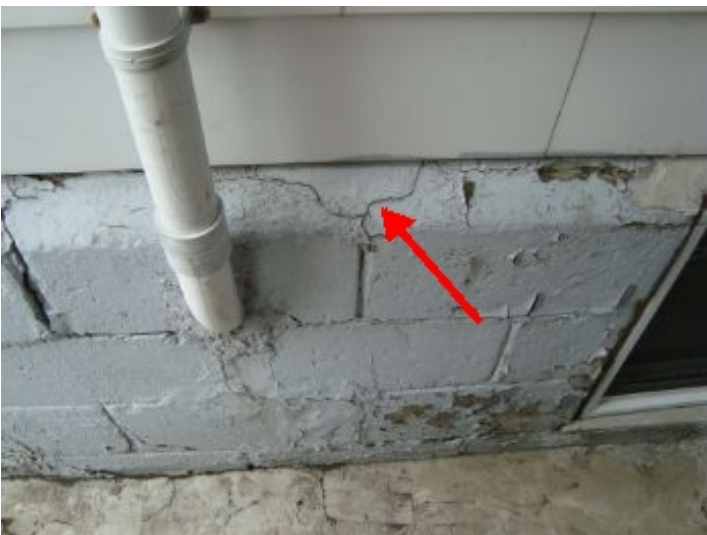
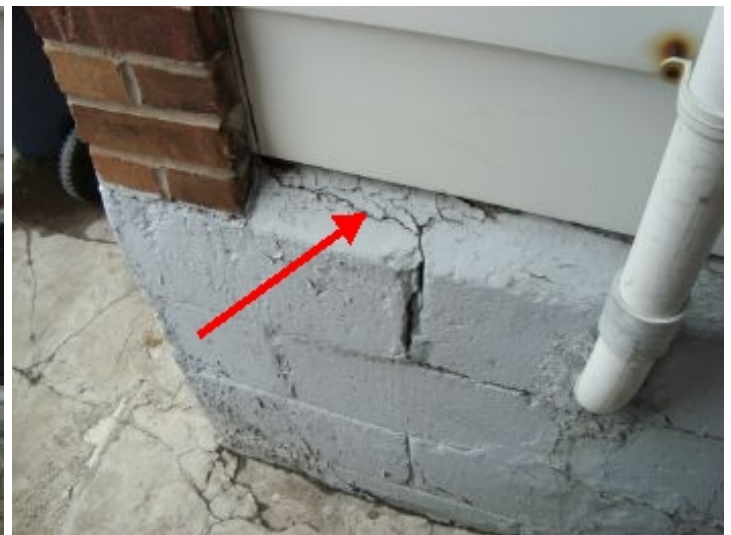
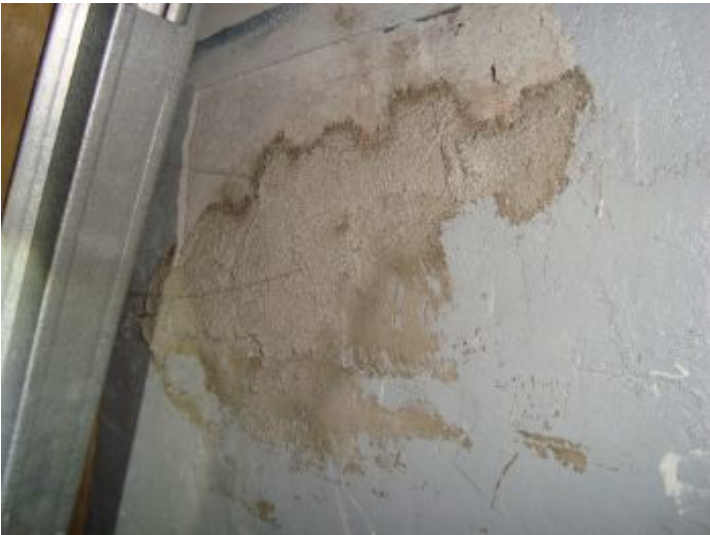
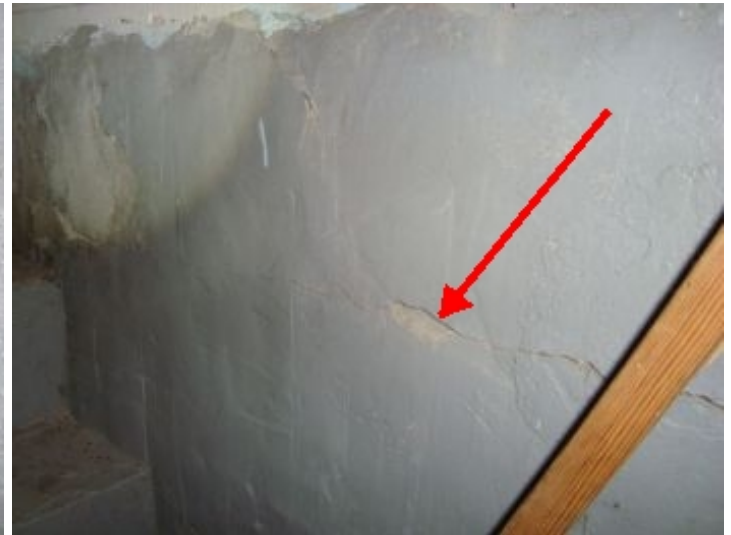
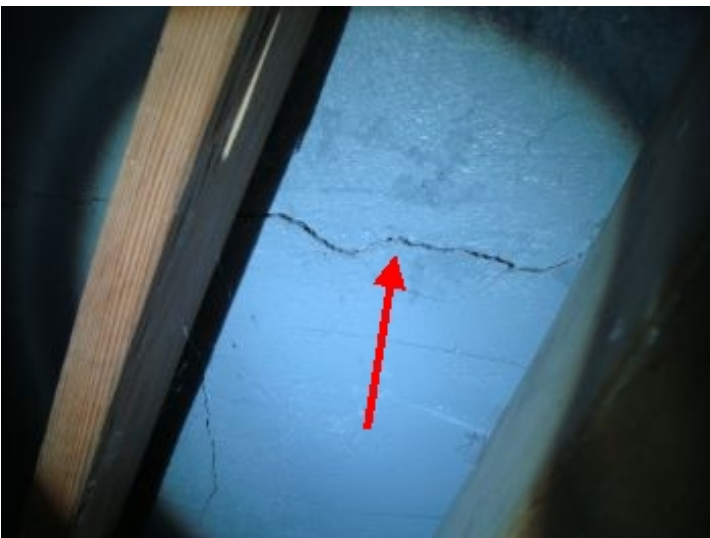
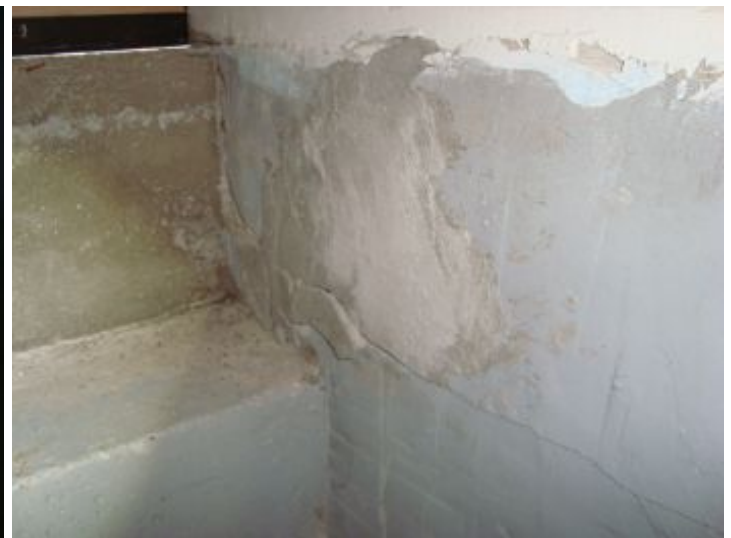
- Basement walkout appears to be added. When such items are added to the house, they effectively lower the frost line and on occasion can sustain frost damage to footings. Buyer is advised to verify building permit and installation process to determine if this has been taken into consideration. We do not tacitly approve any work that was done without a permit and latent defects can exist.
- Common cracks noted, which may leak at any time. Recommend review by a qualified professional for repair or replacement as necessary.
- Basement walkout walls are severely cracked or heaved and should be evaluated and repaired as needed by qualified masonry contractor.

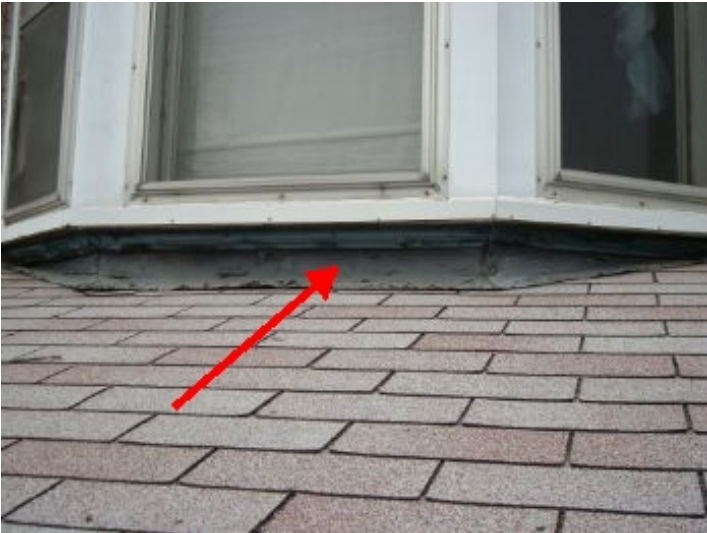
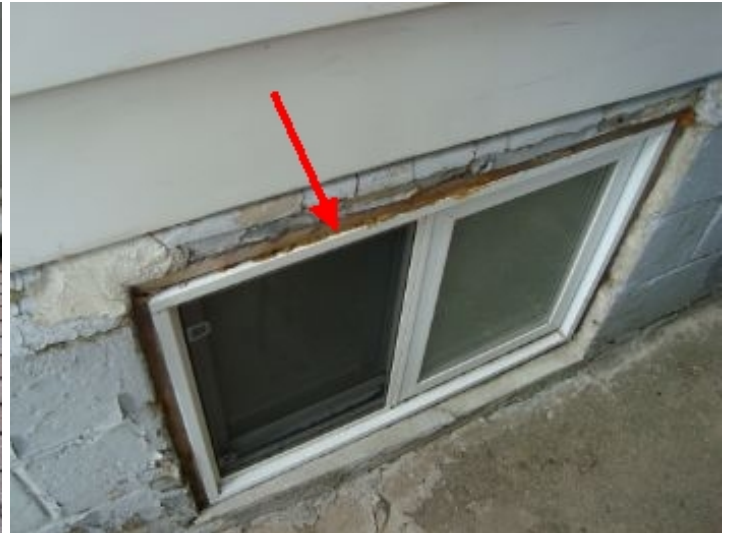
- Window trim is severely weathered on bay window at the front and requires service.
- Replacement basement window has exposed wood that needs to be covered with flashing to prevent water damage.

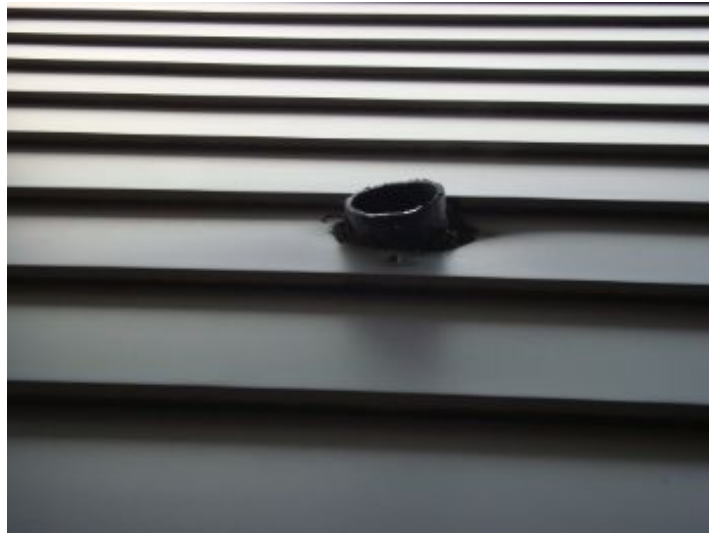
- One or more exhaust duct end caps were missing or damaged. Their purpose is to prevent unconditioned air from entering the building, and keep out birds, rodents and bugs. Blocked ducts can cause fan motors and/or clothes dryers to overheat and may pose a fire hazard. A qualified person should evaluate and repair as necessary.

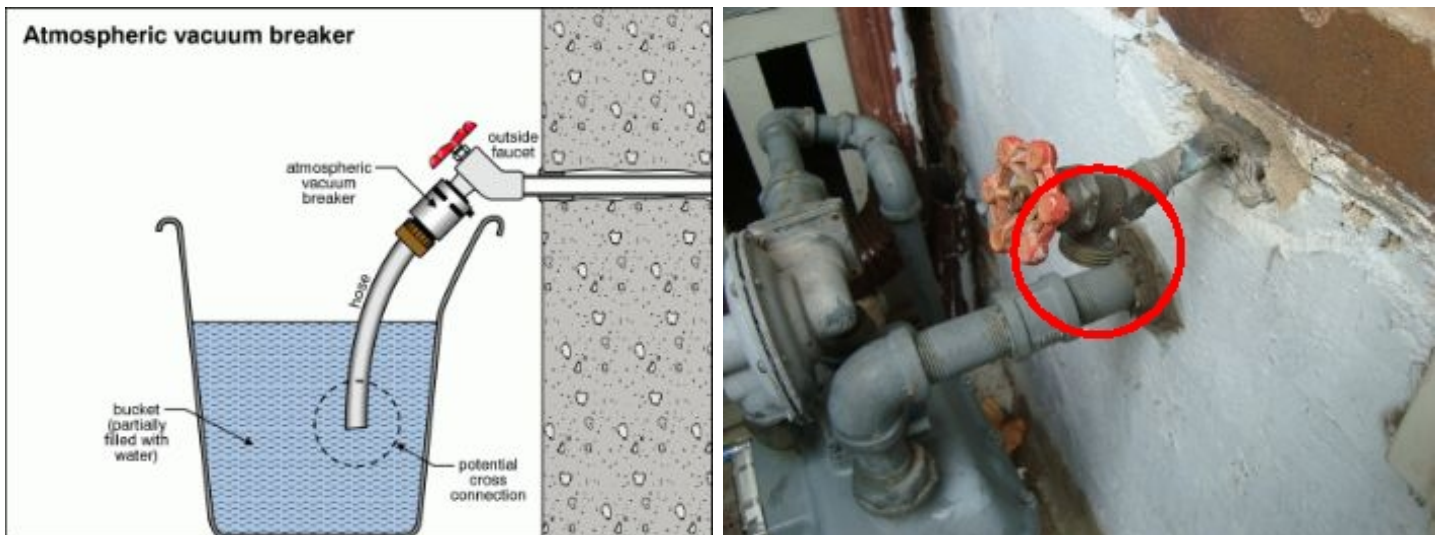
11. Exterior Faucet Conditions

- The hose bibs that were tested are functional but do not include anti-siphon valves. These valves are relatively inexpensive and are required by current standards. Recommend installation of check valve to prevent water backflow.
- Exterior faucets should be winterized prior to cold season to protect pipes from freezing. For proper winterization turn off the inside valve first. Open the bleed valve and drain remaining water. Then open exterior faucet and leave like this for the entire winter.

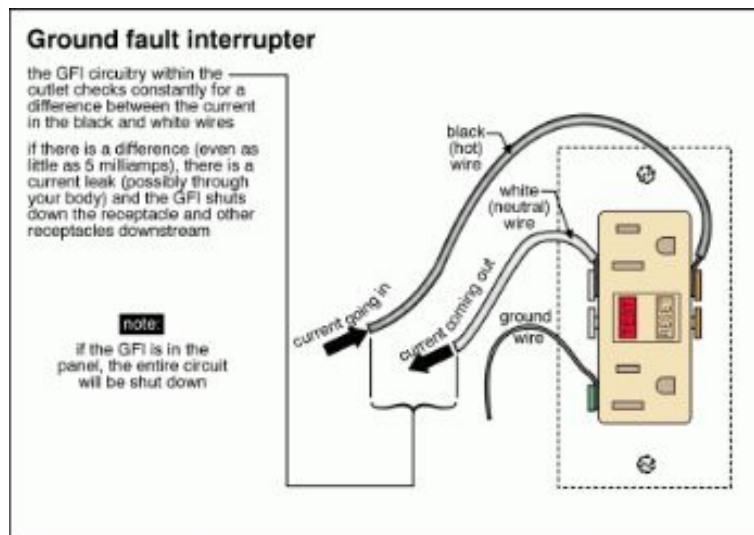
12. Electrical Conditions

- Ground Fault Circuit Interrupters (GFCI) may have not been required when the home was built. However they are important safety feature and I recommend upgrading with GFCI's all exterior receptacles to enhance safety. Upgrades should be performed by a licensed electrician.

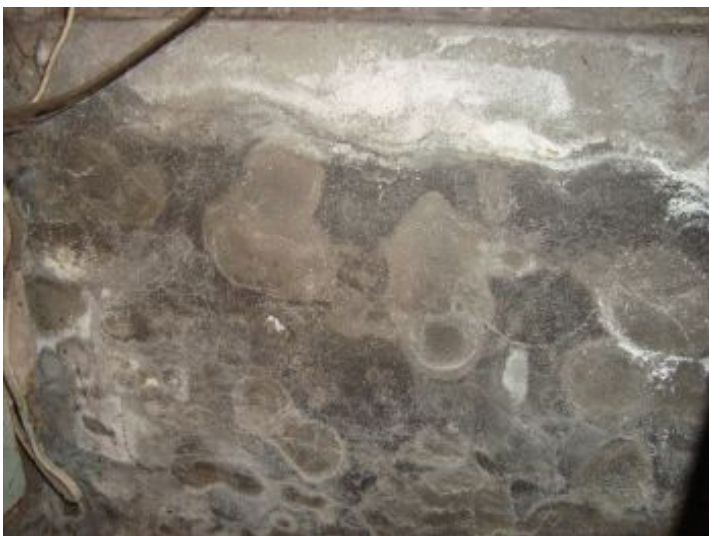
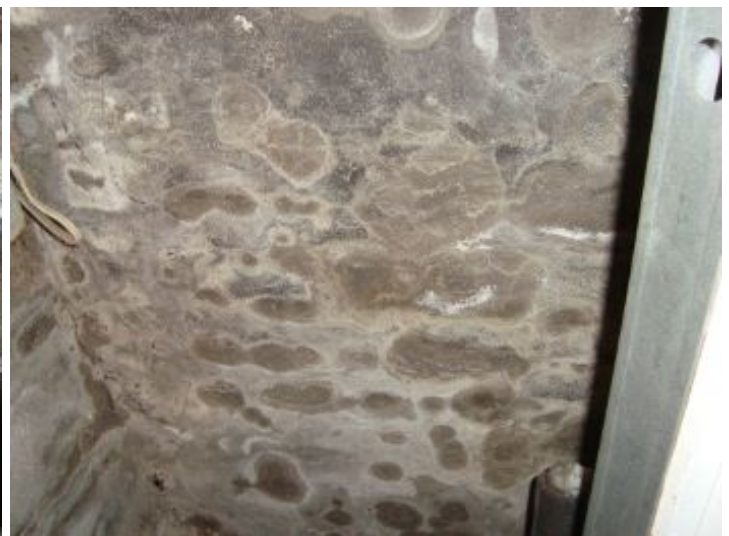
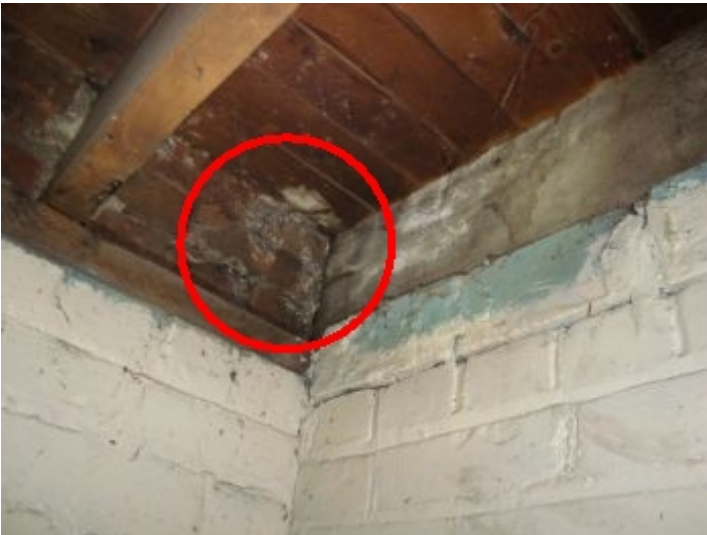
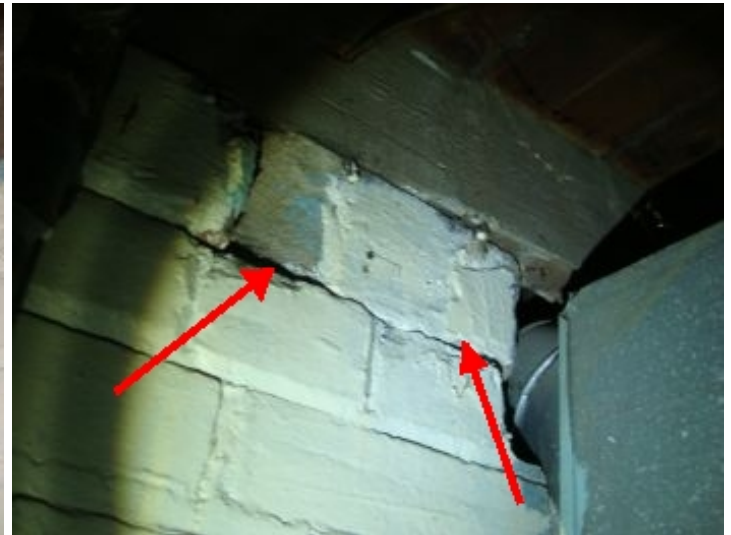
- Although there are no signs of water penetration we caution you to consider any basement as wet until experience proves it dry. Dampproofing materials could loose their integrity with time and allow water seepage through the foundation walls especially after prolonged periods of rain. That is why we encourage you to monitor your foundation regularly and have a working sump pump for emergencies.

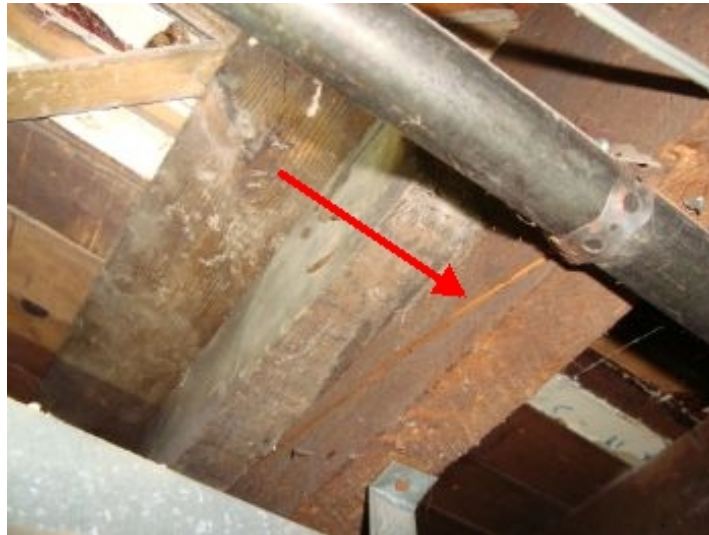
- **Cracked and damaged joists observed. Recommend review by a qualified professional for repair or replacement as necessary.**

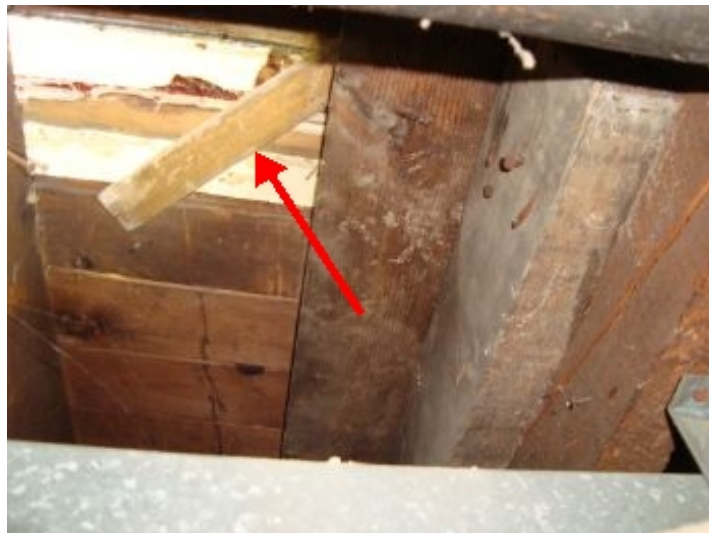
- **Sub floor damage observed. Recommend review by a qualified professional for repair or replacement as necessary.**

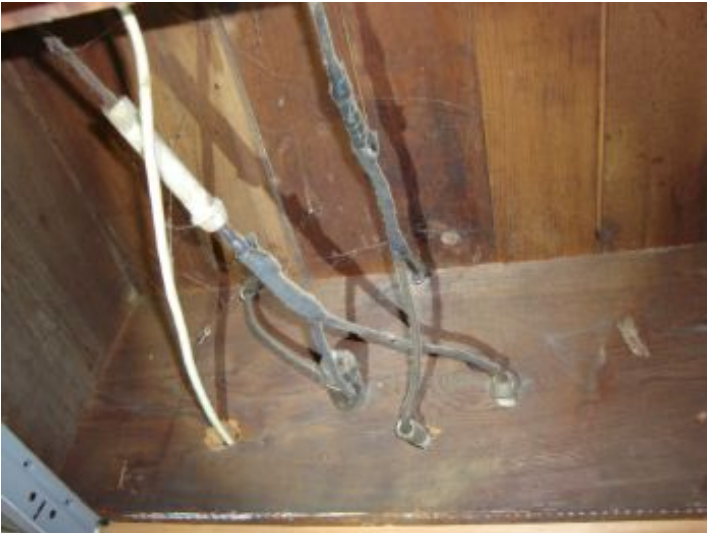
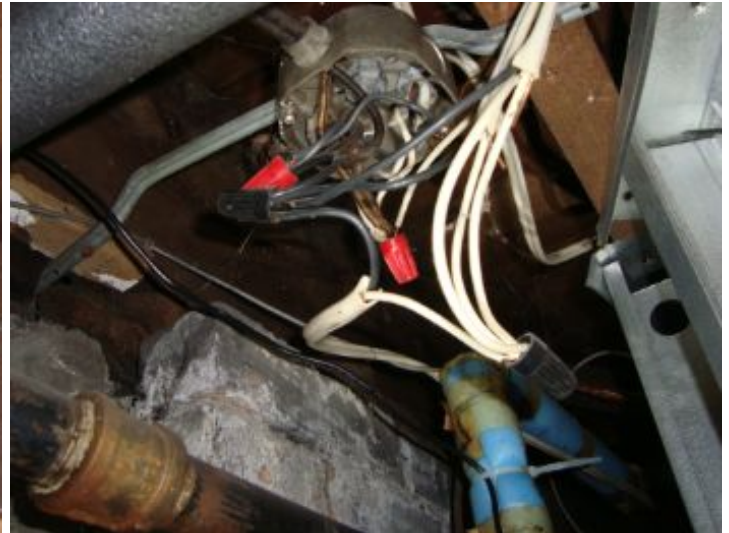
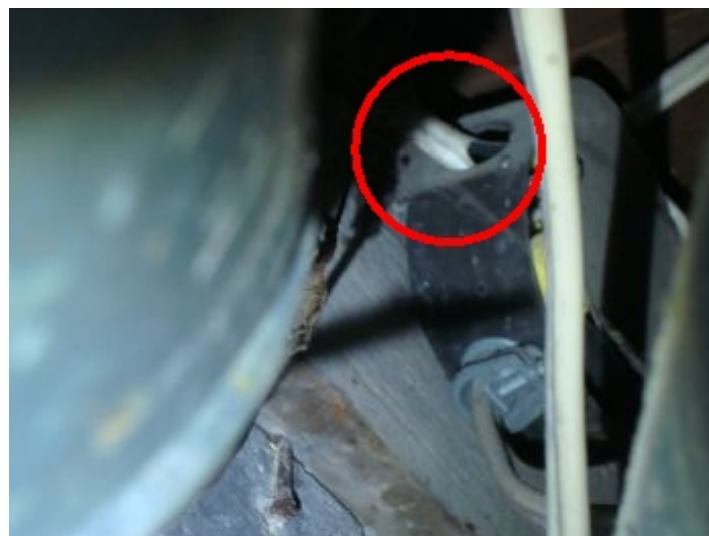
• Evidence of amateur wiring noted. Recommend review for repair or replacement as necessary.

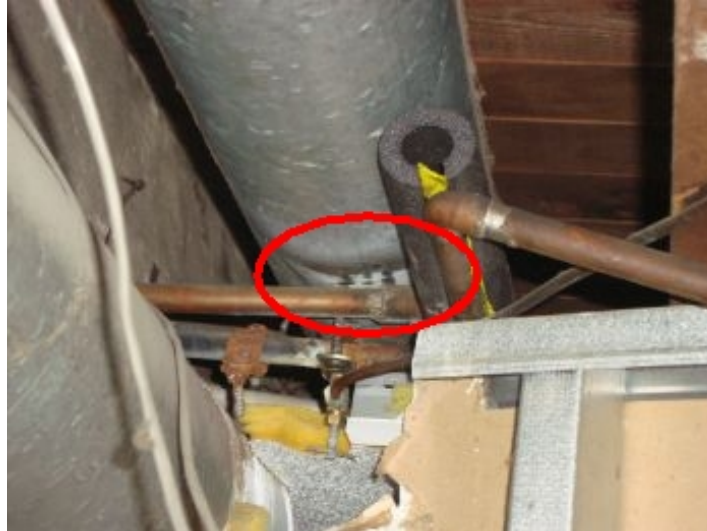
- Copper pipes are in contact with galvanized material. This forms galvanized pair and can create pin holes in copper pipes. Recommend review for separation of the copper pipes from galvanized.

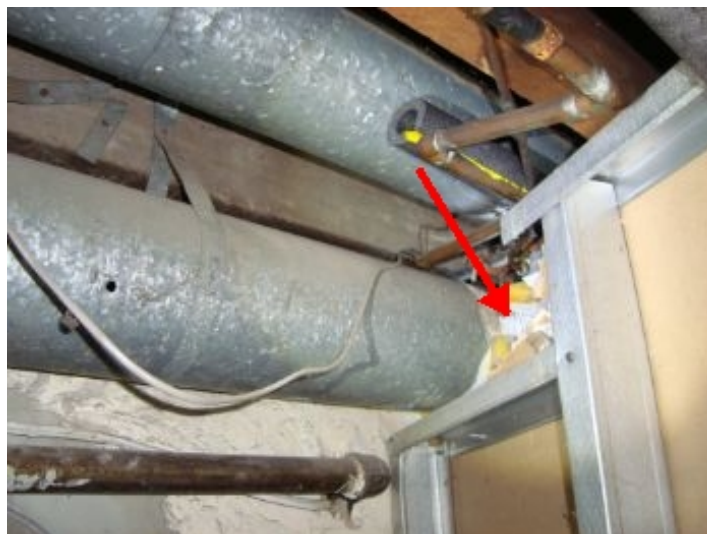
- Possible asbestos materials observed. The materials appeared to be in serviceable condition at the time of inspection. Asbestos materials are considered safe by the EPA if they are not disturbed, torn, ripped, or damaged. No torn, ripped, or damaged materials were observed. If client has any concerns regarding asbestos materials, an asbestos testing lab should be consulted for further review to ensure safety.
- Very limited review of ductwork due to basement finish.

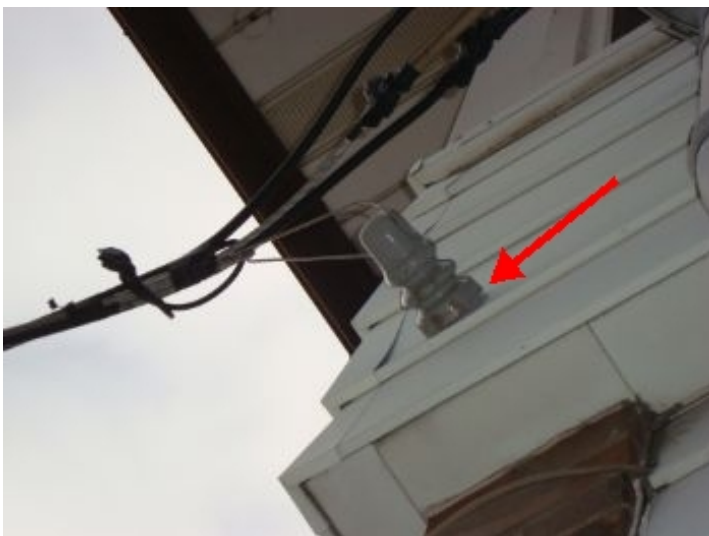
- Wires are sagging, recommend review by the local utility company for repair as necessary.
- Service drop attachment to the house is pulling away from siding and should be secured.

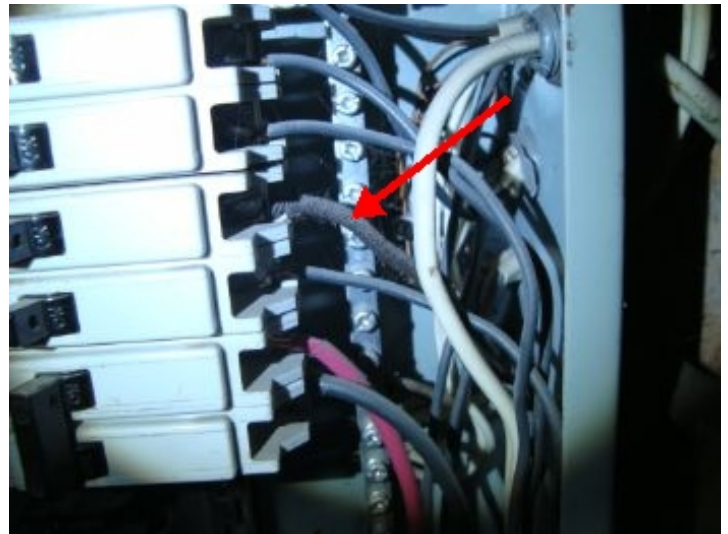
- The system includes old tinted cloth covered wires that should be evaluated by electrician and certify as being safe.

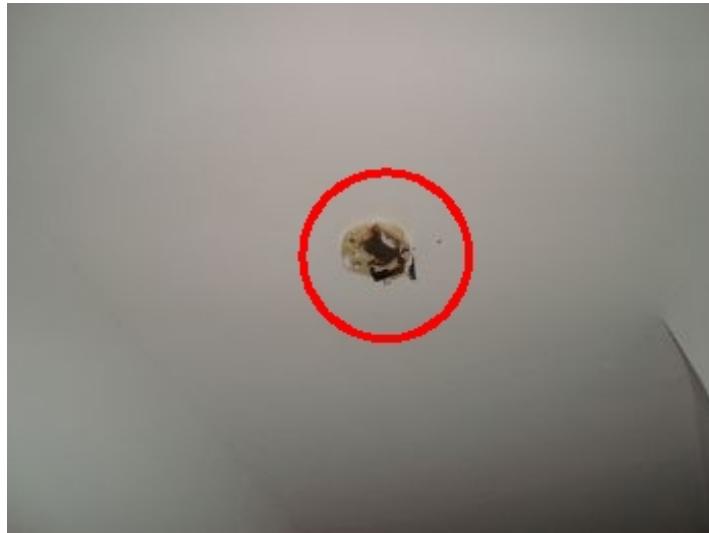
4. Smoke detector comments

- We do not inspect smoke detectors. However they are important safety devices that should be less than 10 years old, installed on each floor, interconnected with each other and have battery backup.
- Buyer is cautioned that, as landlord, he/she is expected to maintain operational smoke and carbon monoxide detectors for protection of tenants.
- Defective smoke detector observed on the ceiling of the second floor hallway. Recommend replacement with new one as required.

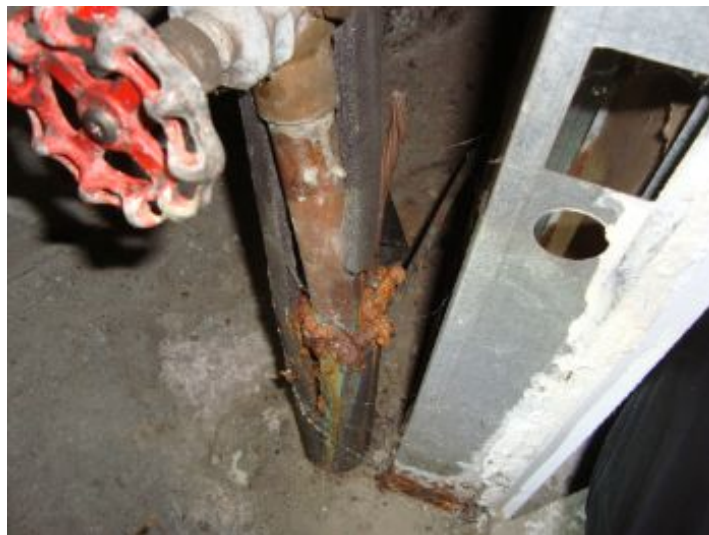
5. Grounding

- No bond wire observed at meter. Recommend installing bond wire to insure proper grounding and safety.
- The panel is grounded to a water pipe.
- **Ground clamp is rusty and needs replacement.**

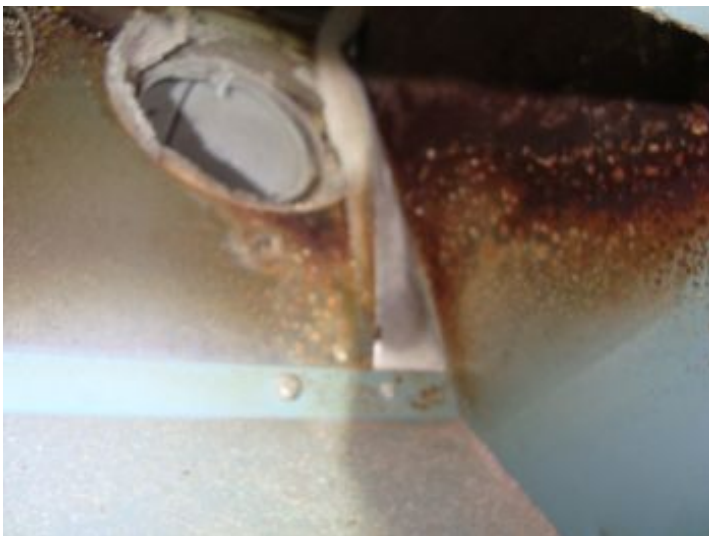
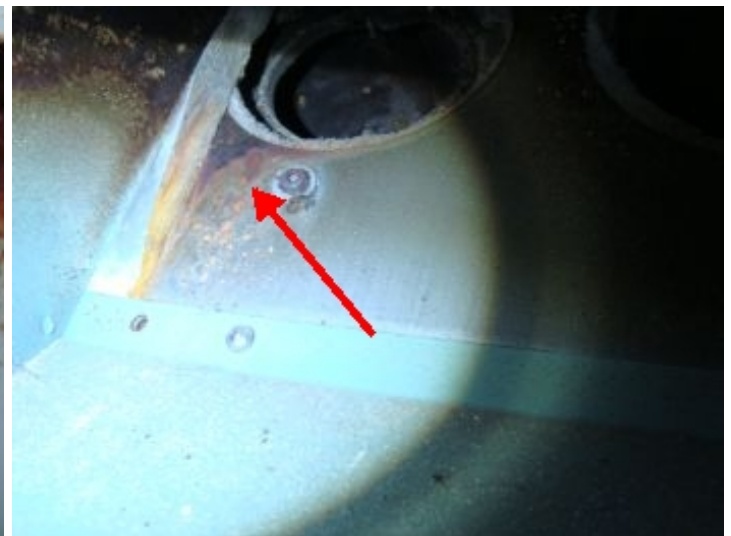
- Annual service is recommended. Suggest having this unit professionally cleaned and tuned to ensure proper and safe operation.
- Due to presence of rust, scale, and some debris in this appliance, a service review by a licensed HVAC contractor is advised to ensure proper and safe operation of this unit. Inspection for holes and/or cracks in heat exchangers is not within the scope of this inspection and should be performed prior to closing to ensure the proper and safe operation of the system.
- Atmospheric furnace is beyond its recommended life expectancy. This furnace shows yellow flame when it was tested. This is an indication of poor combustion or heat exchanger problem. I recommend replacing this furnace immediately with a modern high efficiency unit.

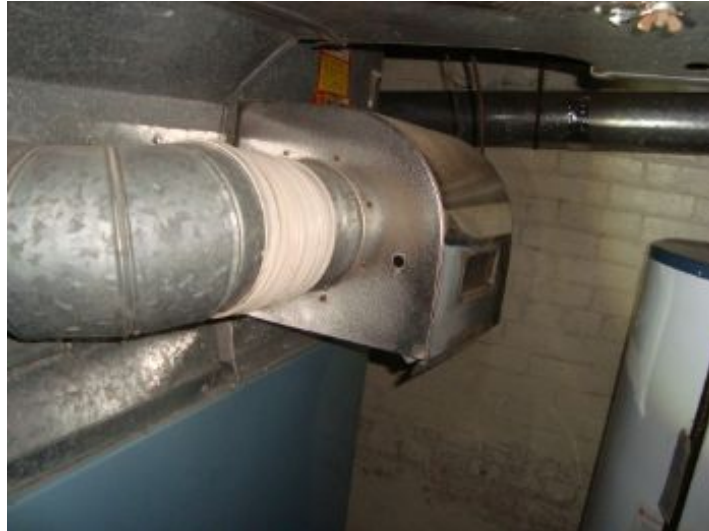
- According to pre-inspection agreement we do not inspect humidifiers.
- Drum humidifiers are prone to leakage and should be replaced with modern cascade or flow through humidifiers.

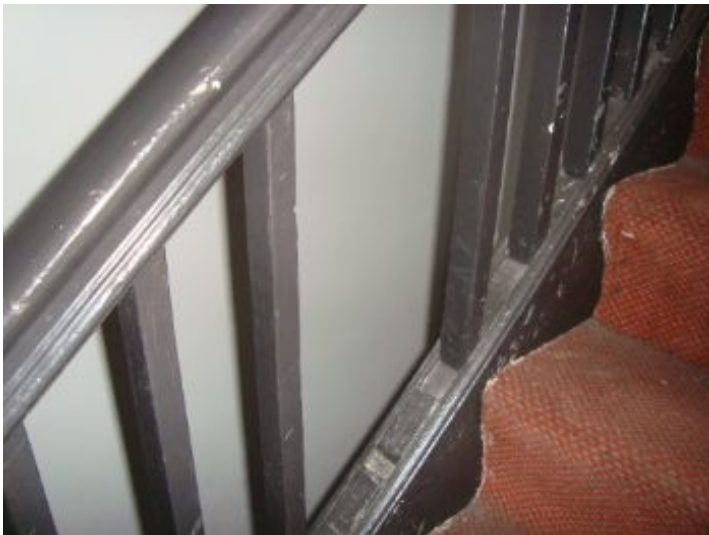
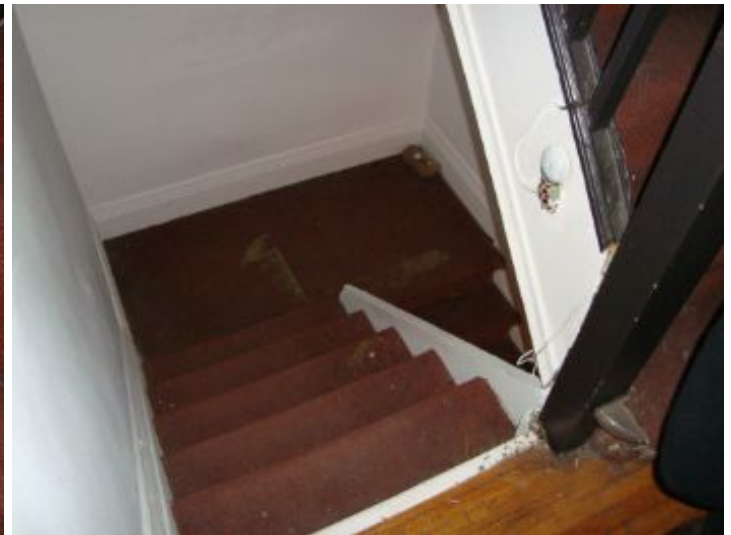
- Missing spindle observed. Recommend review by a qualified specialist and repairs as needed.
- Missing guardrails observed. This is a "Safety Concern". Although guardrails may not have been required when the home was built, we recommend client consider installing guardrails as a safety enhancement.
- Whenever two or more steps are present a handrail is usually required. Recommend review by a qualified professional for repair or replacement as necessary.

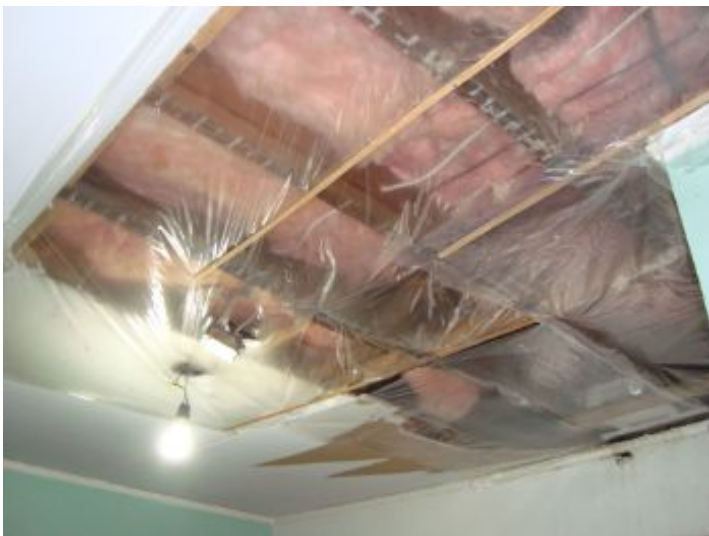
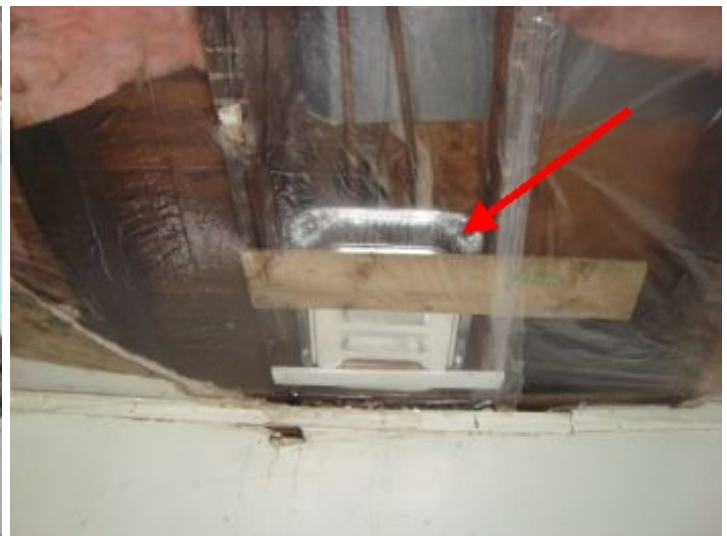
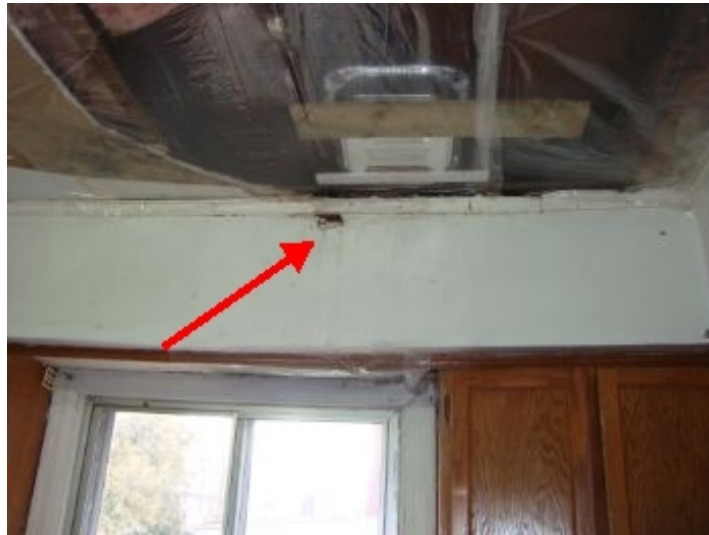
- Evidence of past water penetration observed. Dry at the time of the inspection.
- Significant damage (holes, etc.) were found in one or more ceiling sections. A qualified person should repair as necessary.

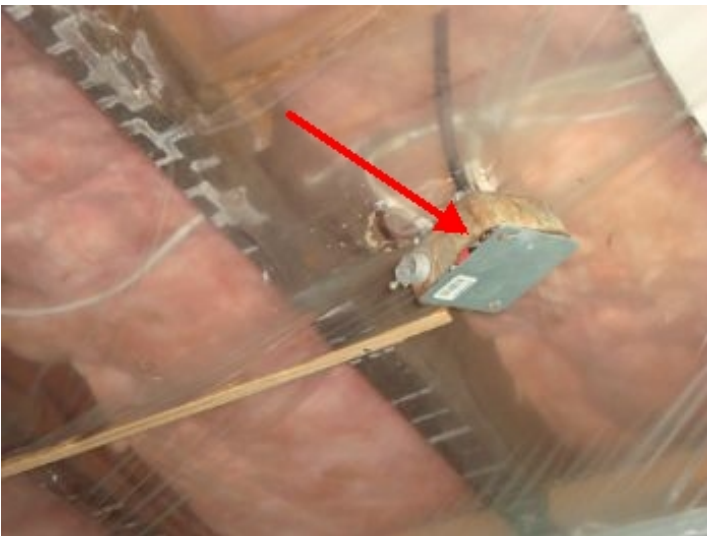
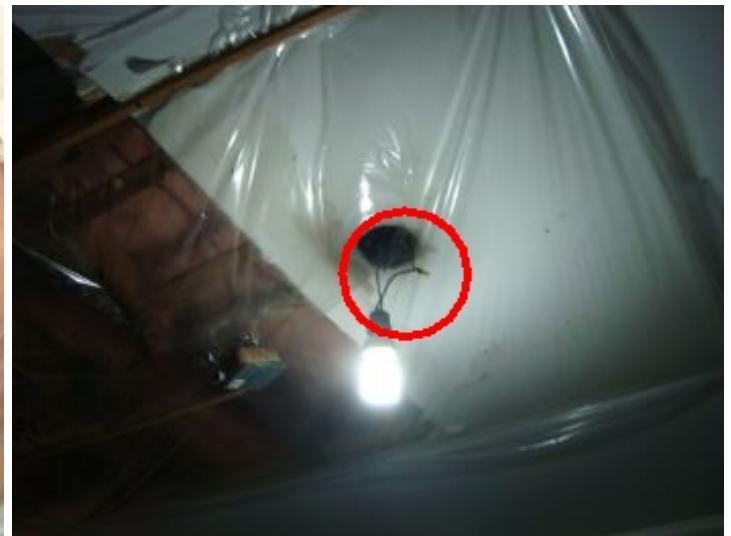
- One or more electric receptacles and/or the boxes they are installed in were loose and/or not securely anchored. Wire conductors may be damaged due to repeated movement and/or tension on wires, or insulation may be damaged. This is a safety hazard due to the risk of shock and fire. A qualified electrician should evaluate and repair as necessary.

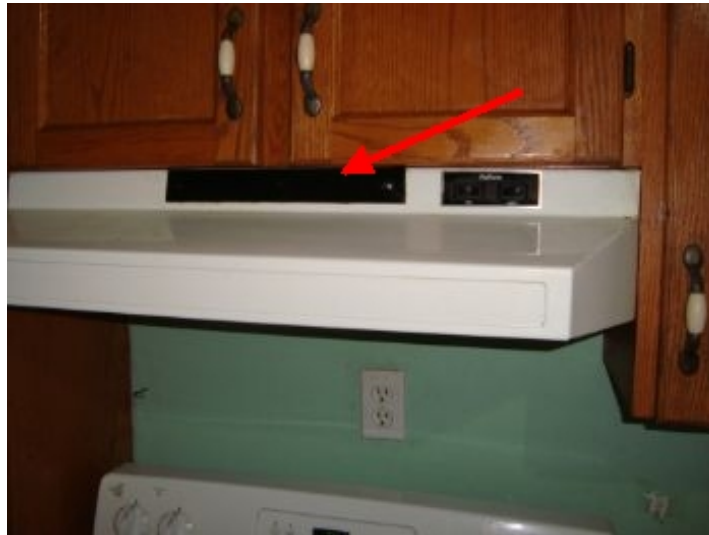
- Exterior vented fans are generally required for proper smell removal.
- Exhaust fan is very noisy and needs service. Recommend review for repair or replacement as necessary.

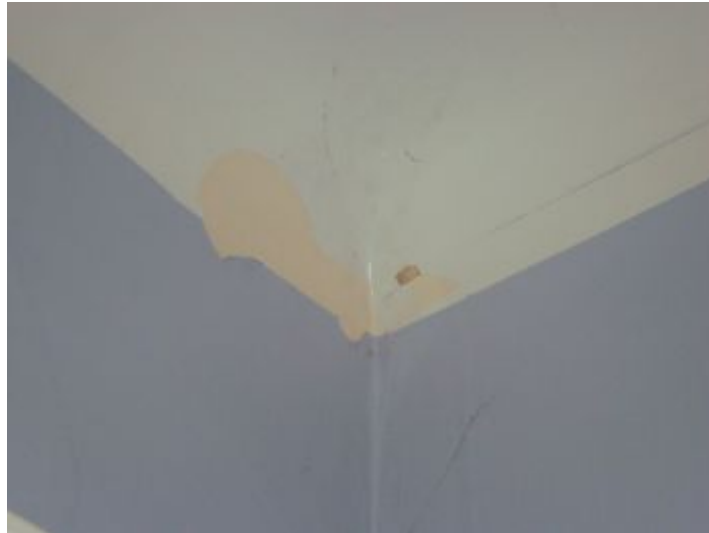
- Minor damage such as peeling paint or spider cracks observed. Recommend review by a qualified professional for repairs as needed.

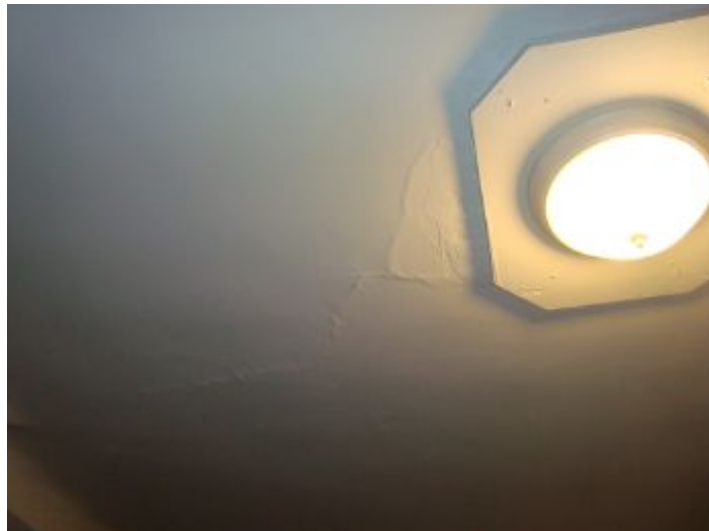
- Significant damage (holes, etc.) were found in one or more ceiling sections. A qualified person should repair as necessary.

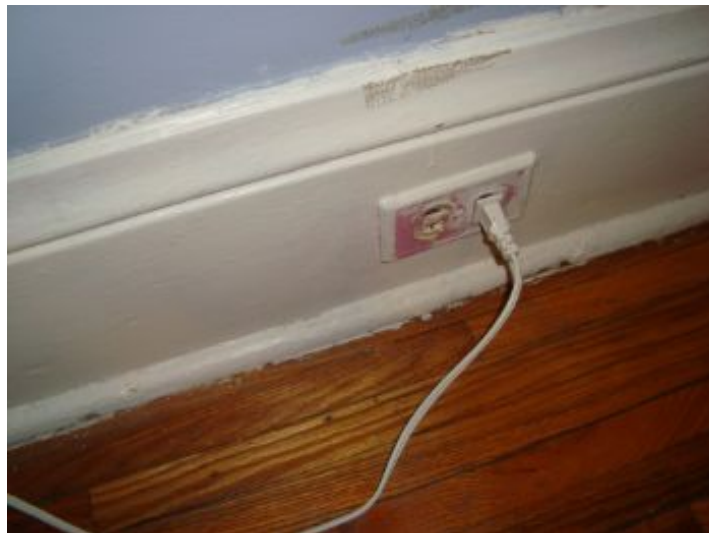
- 2-prong outlet is an older style ungrounded outlet that does not meet modern days requirements. These outlets commonly were ungrounded and can only be used for limited application. Recommend replacement of the 2-prong outlets with GFCI for proper protection.

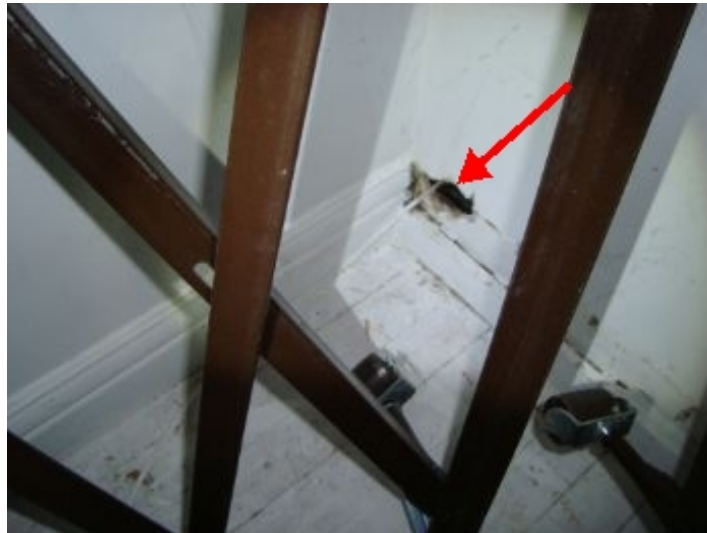
- **Significant damage (holes, etc.) were found in one or more wall sections. A qualified person should repair as necessary.**

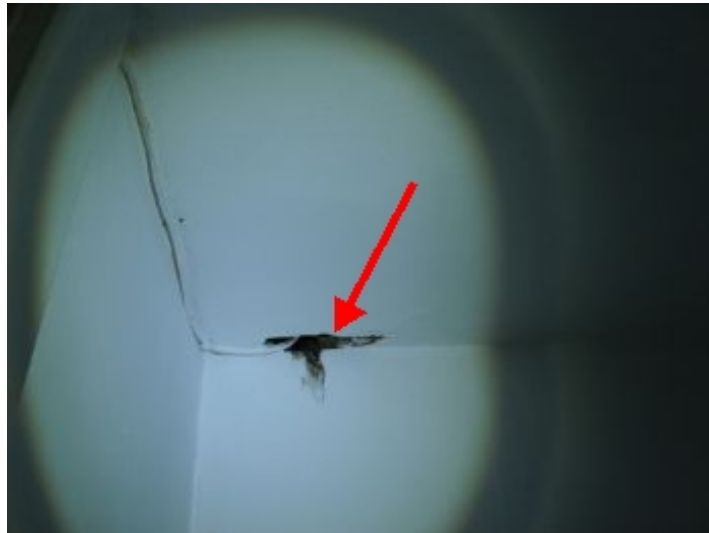
- **Significant damage (holes, etc.) were found in one or more ceiling sections. A qualified person should repair as necessary.**
