Home Inspection Report

Anyname St, Toronto, ON, M0A 1O1

Date of Inspection: 10/16/2012 Time: 1:00 PM
Age of Home: 80 years
Weather: Cold, Windy

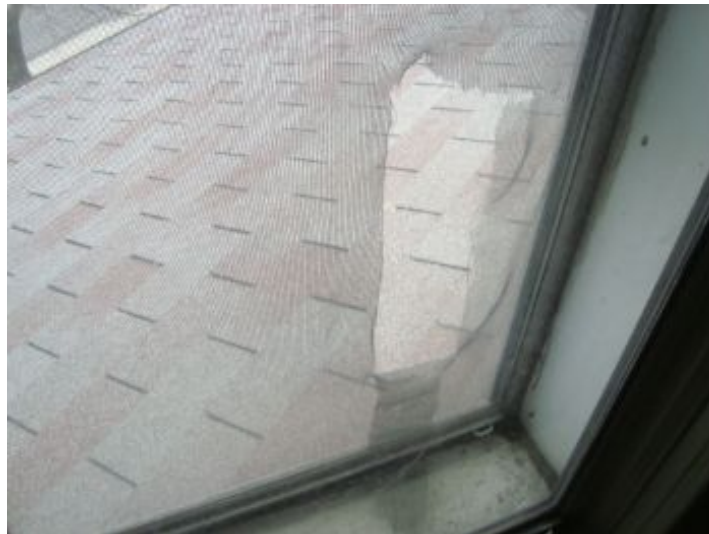
- Damaged screens observed. Recommend repairs as needed.

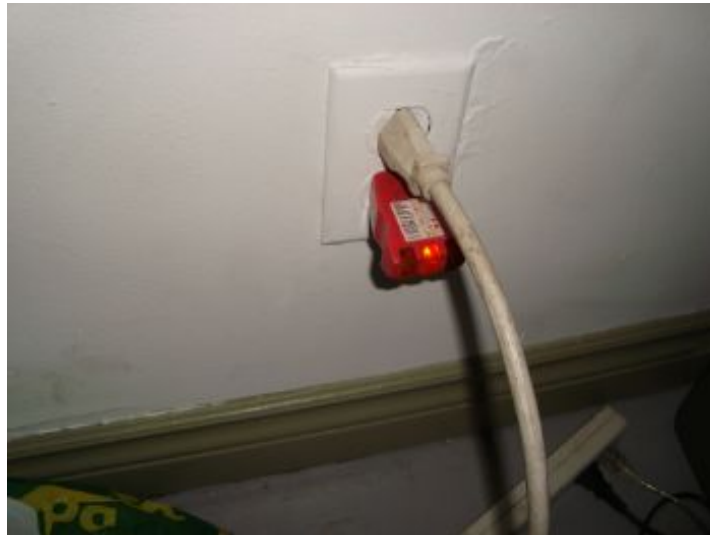
Grounding type receptacles were first required in residential structures during the 1960s. Based on the age of this structure and/or the absence of 2-pronged receptacles, repairs should be made by correcting wiring circuits as necessary so all receptacles are grounded as per standard building practices. Replacement of three-pronged receptacles with 2-pronged receptacles is not an acceptable solution.

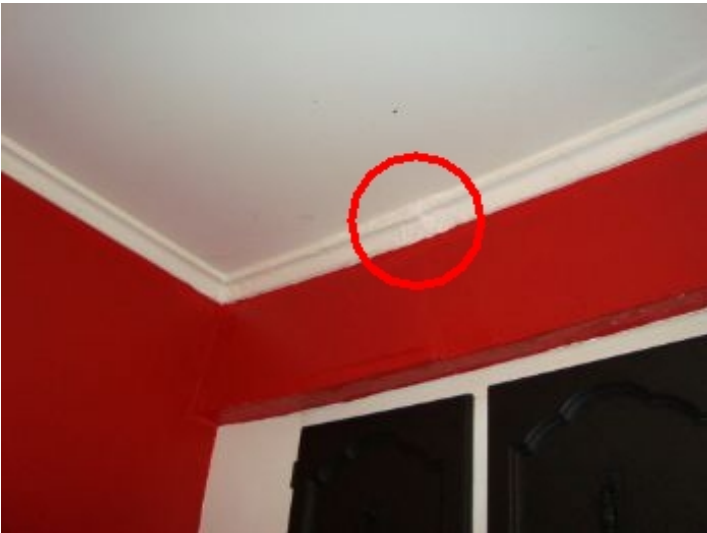
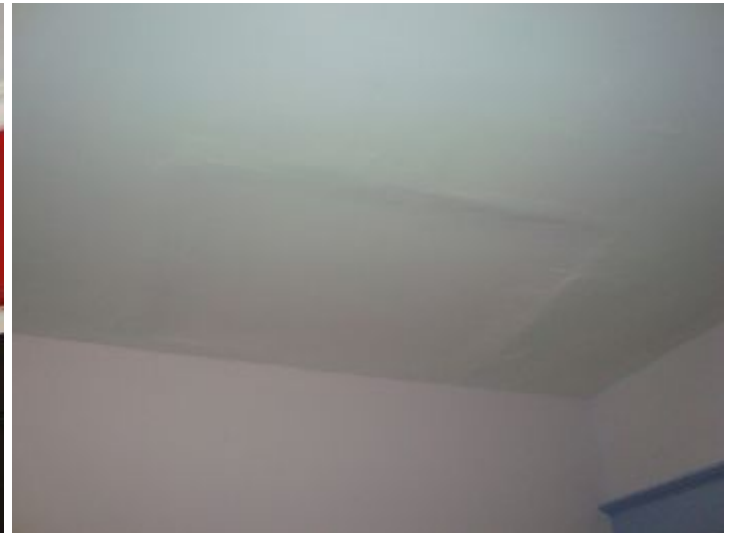
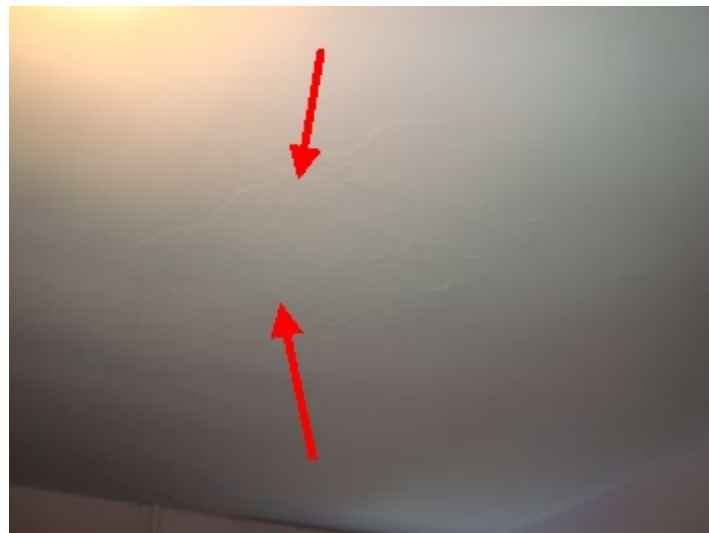
- Minor damage, such as peeling paint or spider cracks observed. Recommend review by a qualified professional for repairs as needed.

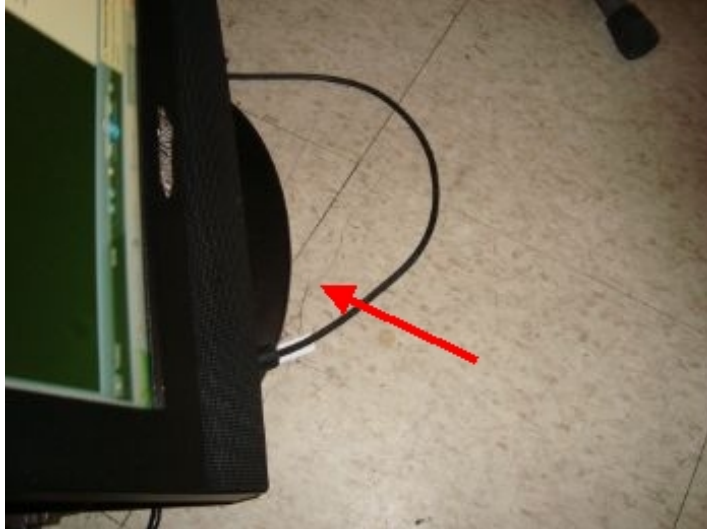
- Tiles are cracked or otherwise worn and should be reviewed for repairs or replacement.

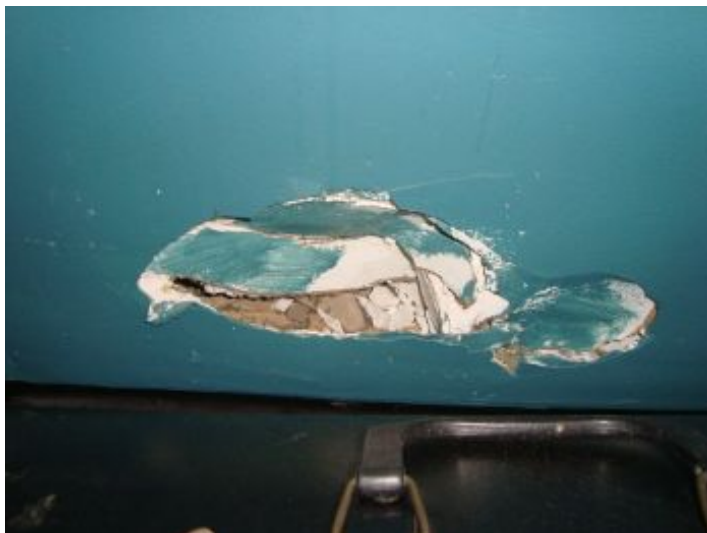
- Significant damage (holes, etc.) were found in one or more wall sections. A qualified person should repair as necessary.

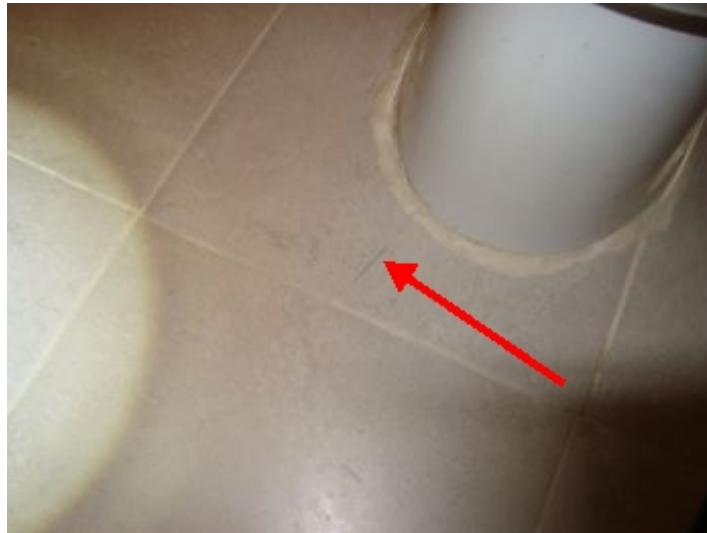
- Common cracks noted. Recommend review for repair or replacement as necessary.

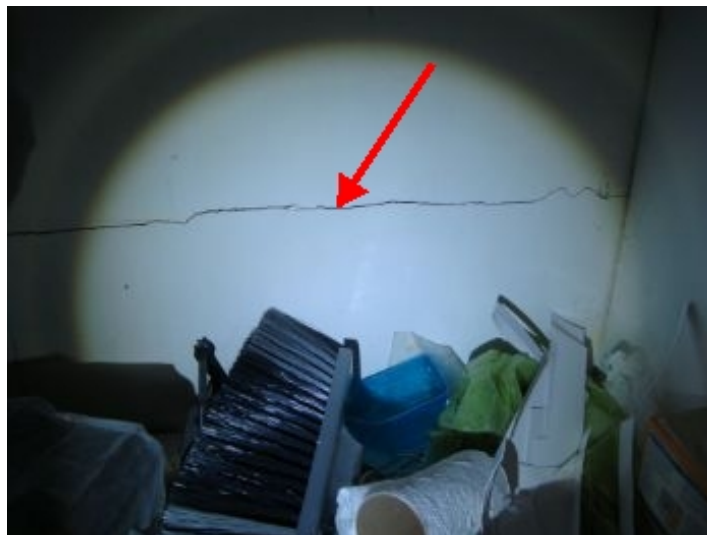
- Evidence of past water penetration observed. Dry at the time of the inspection.
- Significant cracks were found in some walls. This may be a structural concern, or an indication that settlement is ongoing. A qualified contractor should evaluate and repair as necessary.

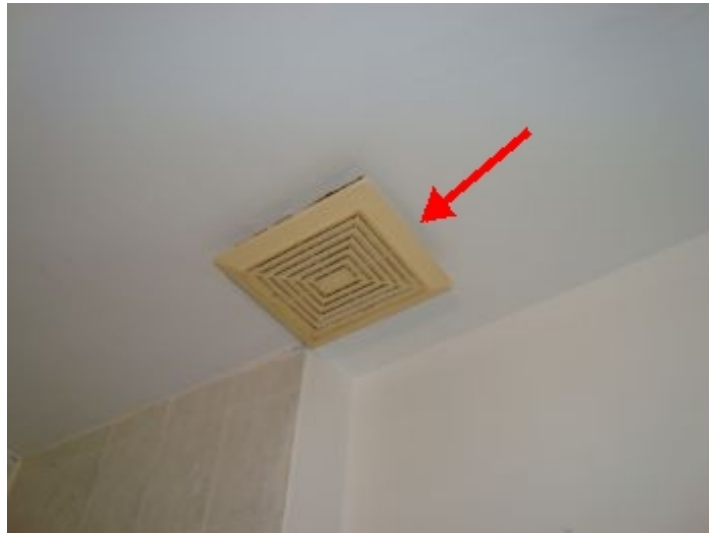
- Functional
- Exhaust fan cover is loose and should be secured.

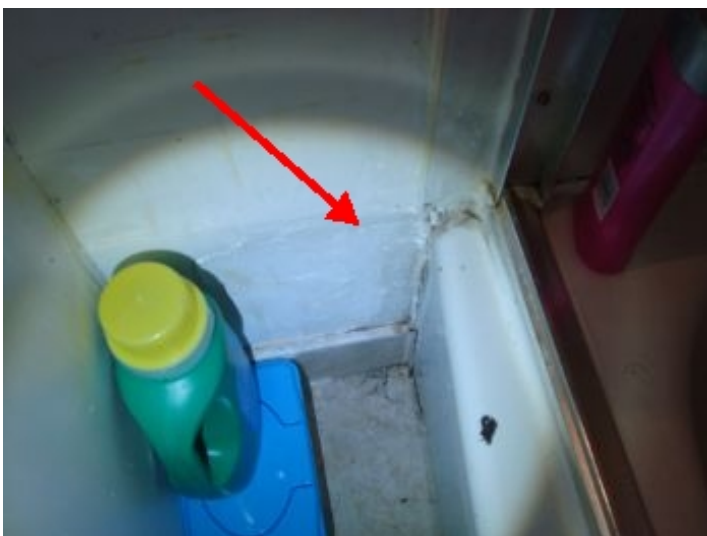
- The wall that is adjacent to the bath tub appears to be moisture damaged. This is not uncommon but requires service. If left unattended it may lead to deterioration of the wall and mold growth. Recommend review by a qualified professional for repairs or replacement as needed.

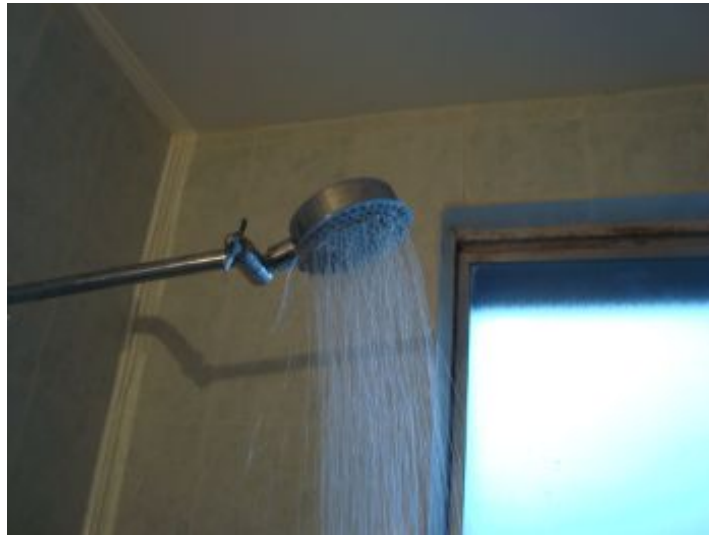
- Shower head leaked or did not work properly. Condition is also noted if water leaks from around the shower head connection to the pipe or if shower head sprays in unusual patterns so that water could damage walls, ceiling, or floors. Condition sometimes is caused by mineral accumulation on the exterior or in the interior of the shower head and sometimes can be resolved by having the shower head cleaned. Recommend repair or replacement.

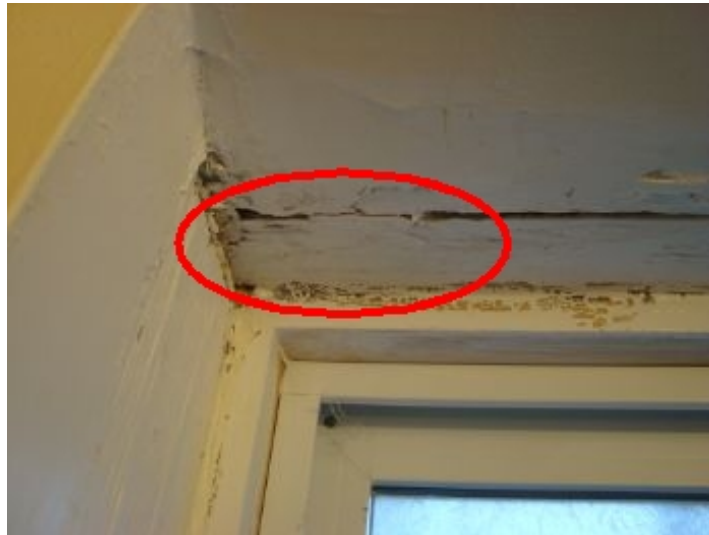
- Window frame appears to have substandard repairs from the previous water damage. Dry at the time of the inspection.

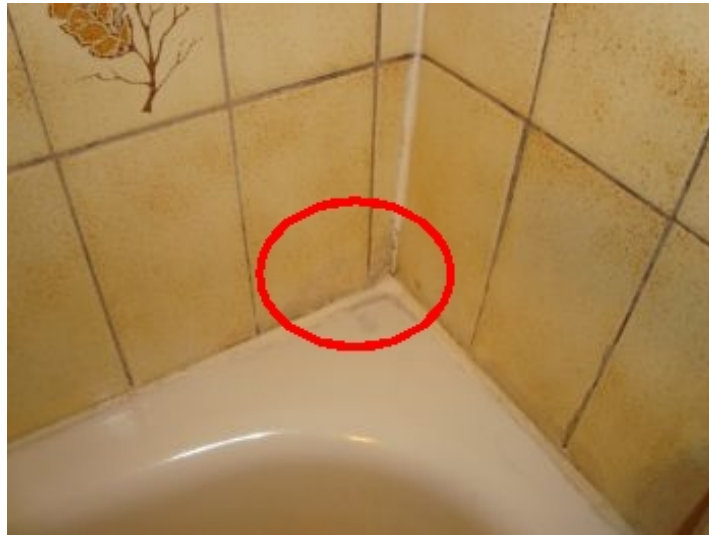
- Mildew observed on the tiles. Recommend clean-up with concentrated laundry detergent. Also recommend installation of the exhaust fan for proper moisture evacuation.

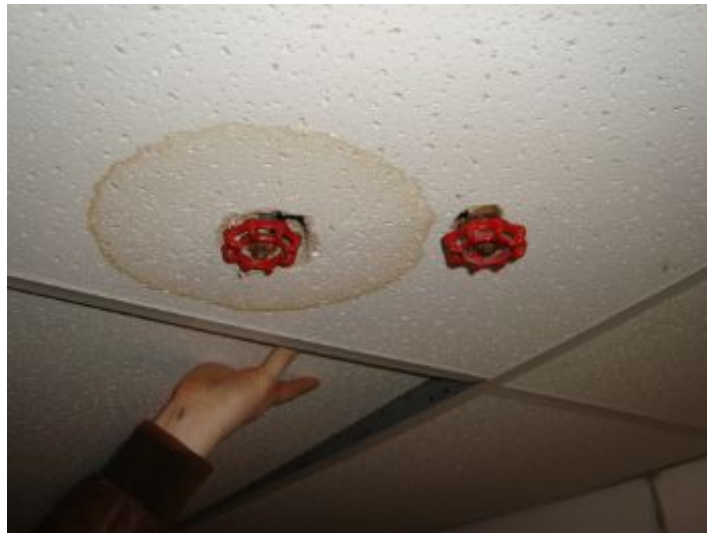
- Evidence of past water penetration observed. Dry at the time of the inspection.

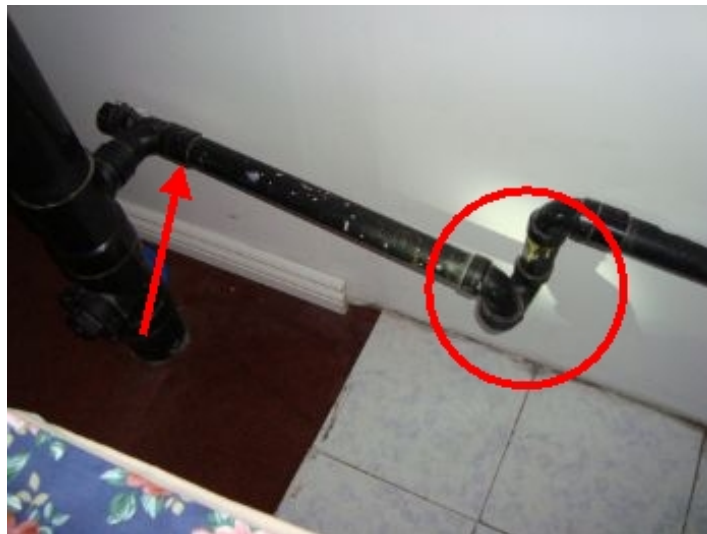
- We do not check appliances as per our agreement. Therefore washer was not operated. We recommend confirming proper operation prior to close.
- Washer discharge drain is improperly connected to the sewer. The trap is located too far from the stand pipe and the drain pipe is run uphill instead of sloping down. Recommend review by a qualified plumber and repairs as needed.
