Home Inspection Report

Anyname St, Toronto, ON, M0A 1O1

Date of Inspection: 10/16/2012 Time: 1:00 PM
Age of Home: 80 years
Weather: Cold, Windy

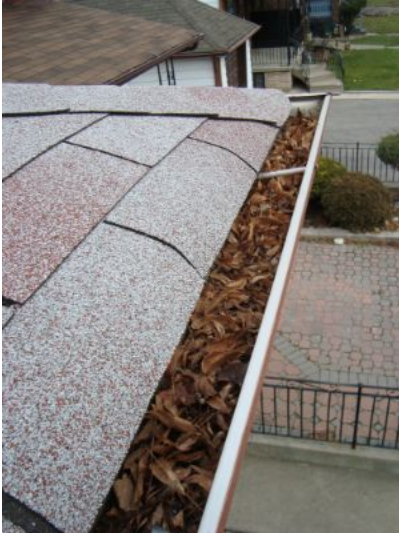
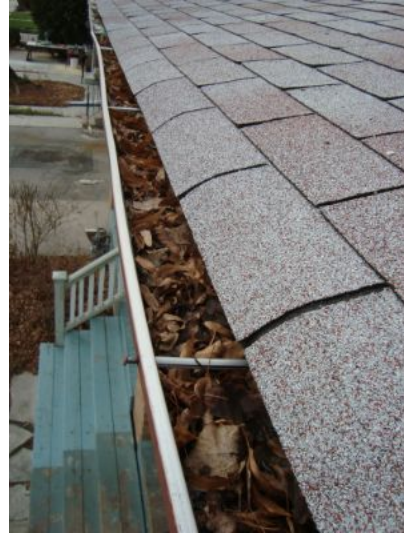
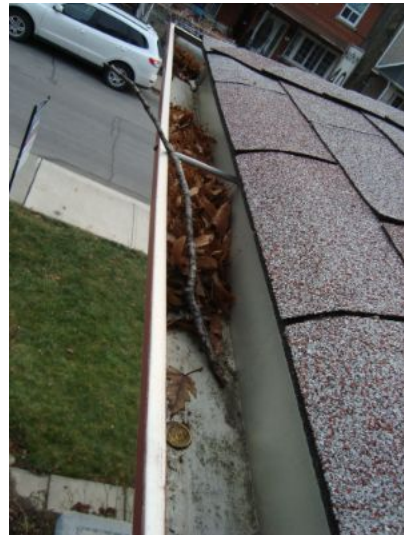
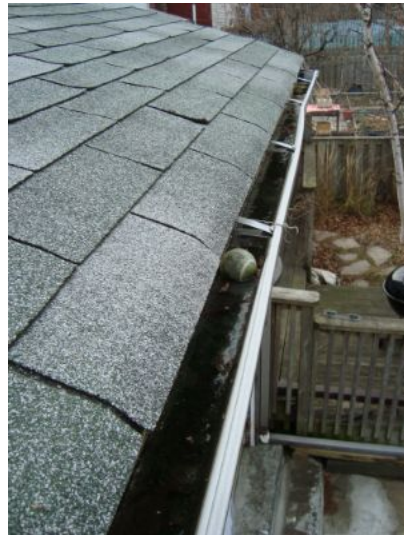
- Debris blocked downspouts observed. Recommend cleaning gutters and downspouts, which should be a regular part of maintenance.
- Clogged gutters noted. Suggest gutters be cleaned out as a part of a normal maintenance routine to ensure proper drainage.
- Downspout at front is loose and should be secured.

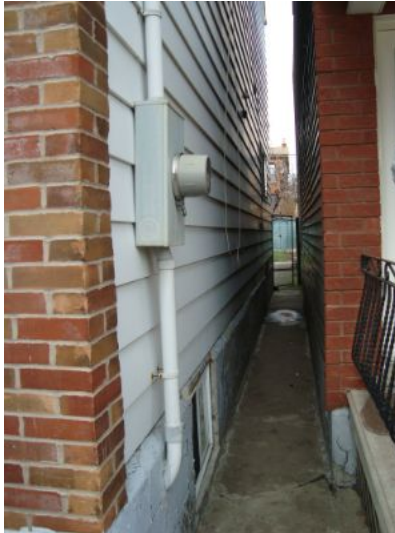
2. Electric Meter Condition

Location: Right Side

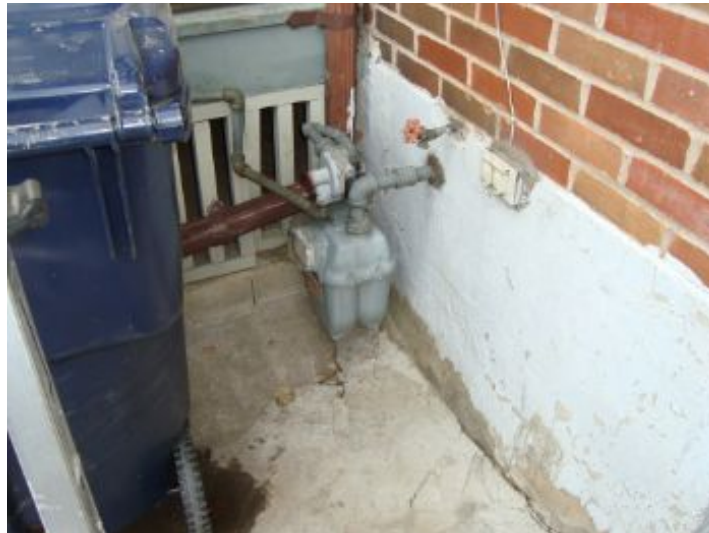
3. Gas Meter Condition

Location: Front

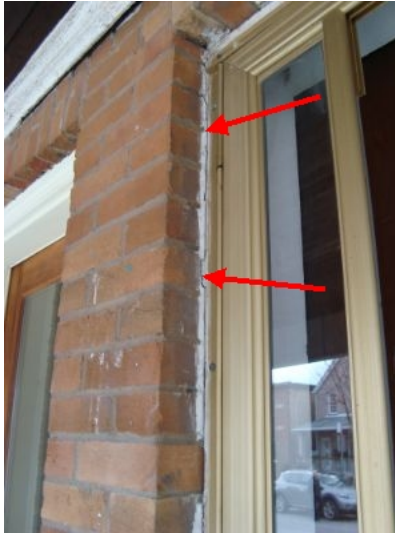
- Caulking around exterior doors is deteriorated and needs replacement.
- Peeling paint observed at front door, suggest scraping and painting as necessary.
- Exterior front door weather strip is missing and should be installed.
- An exterior basement walkout door opens over a step instead of a conventional landing platform. This poses a fall hazard. The doors are required to open over a platform that is at least the width of the door. A qualified specialist should review and repair as needed.

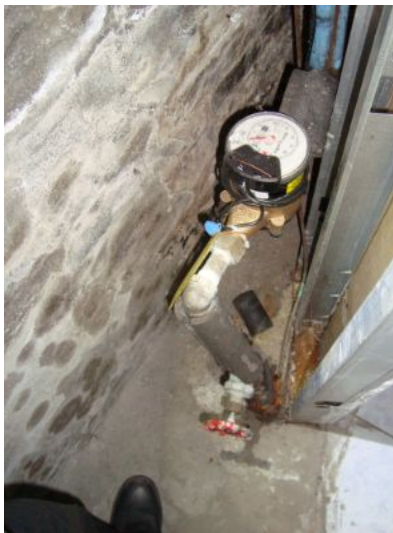
- Since main shutoff valves are operated infrequently, it is not unusual for them to become frozen over time. They often leak or break when operated after a period of inactivity. For this reason main shutoff valves are not tested during a home inspection. We suggest caution when operating shutoffs that have not been turned for a long period of time. All shutoff valves and angle stops should be turned regularly to ensure free movement in case of emergency.
- Basement near electrical panel.

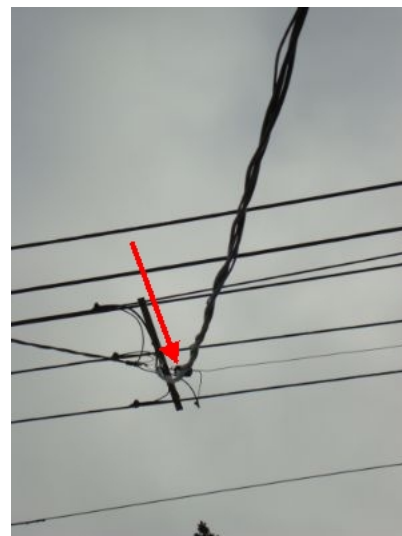
Electrical		
Page 36 Item: 1	Main Service Drop Condition	<ul style="list-style-type: none"> • Wires are sagging, recommend review by the local utility company for repair as necessary. • Service drop attachment to the house is pulling away from siding and should be secured.

- Wires are sagging, recommend review by the local utility company for repair as necessary.
- Service drop attachment to the house is pulling away from siding and should be secured.

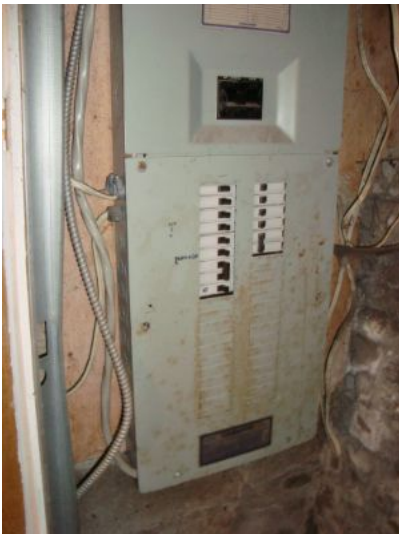
Page 37 Item: 3	Main Panel Comments	<ul style="list-style-type: none"> • Knob and tube wiring noted. While this wiring was standard at time of construction, replacement is now required for insurance purposes. Replacement costs very greatly, depending on extent of replacement as well as by contractor. Buyer advised to contact qualified electrical contractor(s) for replacement quotes. • Excessive rust was observed in the main service panel. This is a result of excessive moisture condensation or water intrusion. It presents safety hazard. A qualified electrician should investigate this further and provide repairs or replacement as needed. • Knob and tube wiring with additional spliced wires observed. This is a "Safety Concern". Suggest review by licensed electrician prior to closing to ensure this system is properly and safely installed. • The system includes old tinted cloth covered wires that should be evaluated by electrician and certify as being safe.

- Knob and tube wiring with additional spliced wires observed. This is a "Safety Concern". Suggest review by licensed electrician prior to closing to ensure this system is properly and safely installed.

- The system includes old tinted cloth covered wires that should be evaluated by electrician and certify as being safe.

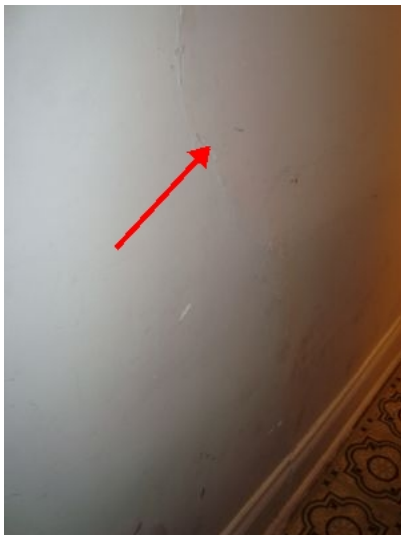
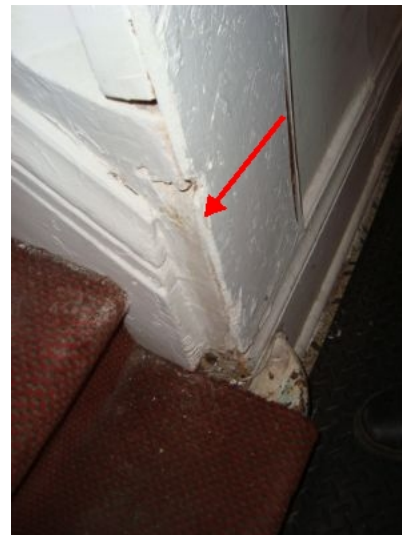
Page 45 Item: 2	Walls Condition	<ul style="list-style-type: none"> Major cracks were found in some wall areas. These appear to be a structural concern, and may indicate that settlement is ongoing. The client is strongly advised to hire qualified contractors and/or engineers as necessary for further evaluation. Such contractors may include: <p>[*]Foundation repair contractors who may prescribe repairs, and will give cost estimates for prescribed repairs [*]Geotechnical engineers who attempt to determine if settlement is ongoing, and what the cause of the settlement is [*]Structural engineers who determine if repairs are necessary, and prescribe those repairs</p>
Second Floor Hallway		
Page 47 Item: 4	Electrical Conditions	<ul style="list-style-type: none"> Reversed polarity, hot and neutral reversed and other terms used for electric receptacles are usually easily corrected by minor wiring adjustments at the specified item. When these conditions are noted in this report, a licensed electrician should be consulted for repairs/replacement as needed to ensure safety.

[*]Geotechnical engineers who attempt to determine if settlement is ongoing, and what the cause of the settlement is

[*]Structural engineers who determine if repairs are necessary, and prescribe those repairs

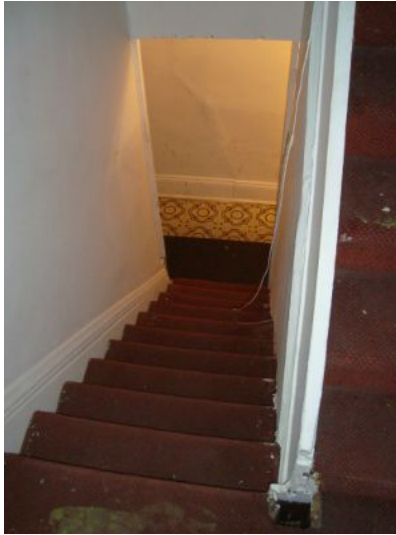
Page 47 Item: 5	Stair Conditions	<ul style="list-style-type: none"> Missing guardrails observed. This is a "Safety Concern". Although guardrails may not have been required when the home was built, we recommend client consider installing guardrails as a safety enhancement. Whenever two or more steps are present a handrail is usually required. Recommend review by a qualified professional for repair or replacement as necessary.
Kitchen		
Page 49 Item: 3	Ceiling Condition	<ul style="list-style-type: none"> Significant damage (holes, etc.) were found in one or more ceiling sections. A qualified person should repair as necessary.
Page 50 Item: 6	Kitchen Electrical Condition	<ul style="list-style-type: none"> One or more electric receptacles and/or the boxes they are installed in were loose and/or not securely anchored. Wire conductors may be damaged due to repeated movement and/or tension on wires, or insulation may be damaged. This is a safety hazard due to the risk of shock and fire. A qualified electrician should evaluate and repair as necessary.

- Missing spindle observed. Recommend review by a qualified specialist and repairs as needed.
- Missing guardrails observed. This is a "Safety Concern". Although guardrails may not have been required when the home was built, we recommend client consider installing guardrails as a safety enhancement.
- Whenever two or more steps are present a handrail is usually required. Recommend review by a qualified professional for repair or replacement as necessary.

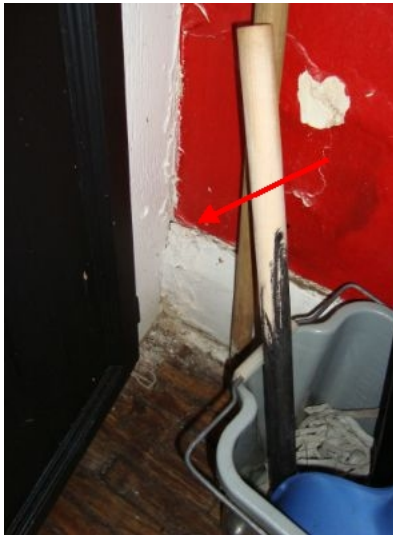
- Significant damage (holes, etc.) were found in one or more wall sections. A qualified person should repair as necessary.

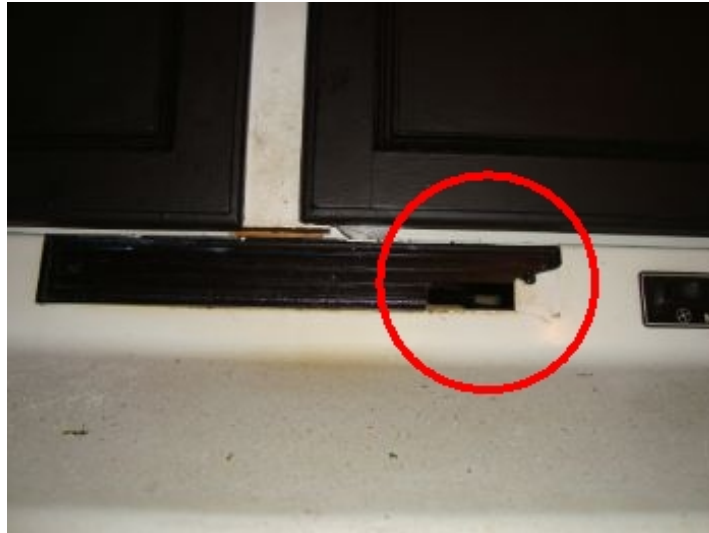
- Exterior vented fans are generally required for proper smell removal.

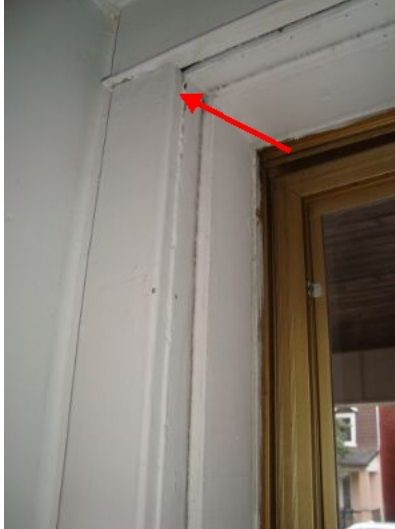
- Deterioration of wooden frames noted. While basic maintenance may prolong the life of these window frames, replacement may be necessary at some point.

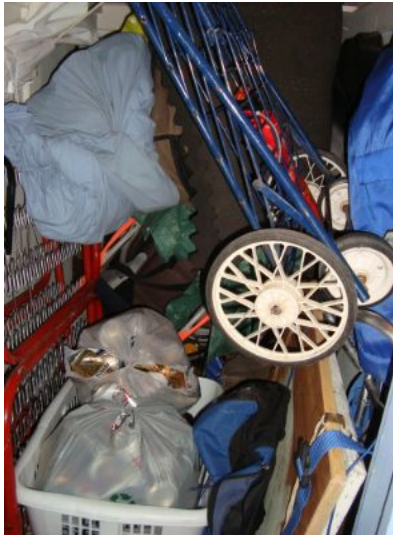
- The closet was full of storage and could not be inspected.

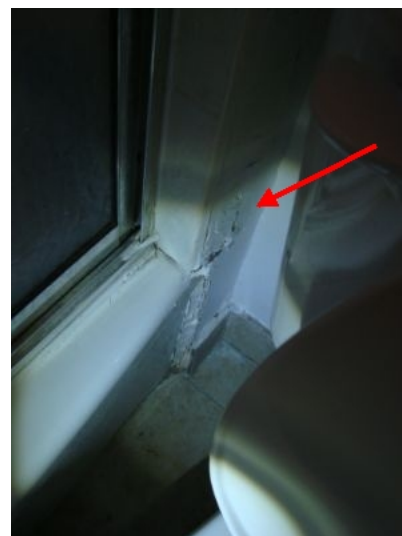
- The wall that is adjacent to the bath tub appears to be moisture damaged. This is not uncommon but requires service. If left unattended it may lead to deterioration of the wall and mold growth. Recommend review by a qualified professional for repairs or replacement as needed.

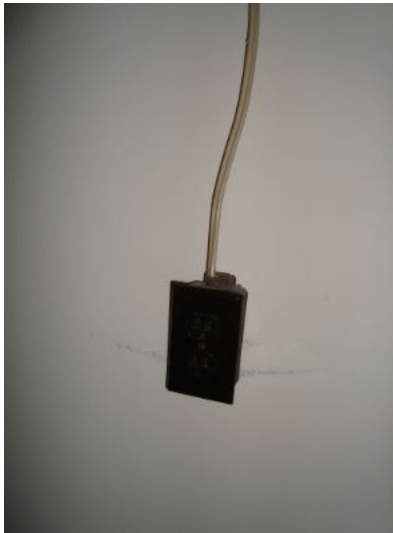
- Loose receptacle observed. Suggest securing as needed.
- Ungrounded receptacles observed at water sources or exterior locations ideally should be grounded, suggest installing GFCI's for safety.

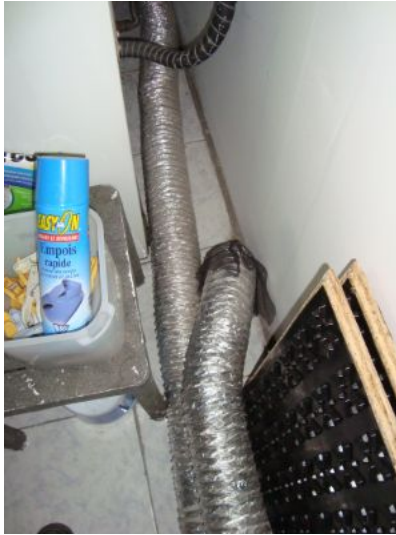
- Gas
 - Dryer
- [[RecallChek Brand]GE
[[RecallChek Model]]VG9100MW119
- Faulty dryer vents have been responsible for thousands of fires, hundreds of injuries, and even deaths. The best vents are a smooth-walled metal type that travels a short distance; all other types should be regarded as suspect, and should be inspected bi-annually to ensure that they do not contain trapped lint or moisture.
 - As per our agreement we do not test appliances. Therefore dryer was not operated and we recommend confirming proper operation prior to close.
 - Dryer vent is disconnected and can only vent inside. The dryer vent should be routed to the exterior and installed per manufacturer's recommendations.
